A STRATEGY FOR DEVELOPING  
INDIGENOUS BUILDING IN  
EARTHQUAKE REGIONS

CASE STUDIES OF THE BANDAR ABBAS 1977 EARTHQUAKE  
AND THE ZARAND 1978 EARTHQUAKE

BY  
DEVELOPMENT WORKSHOP

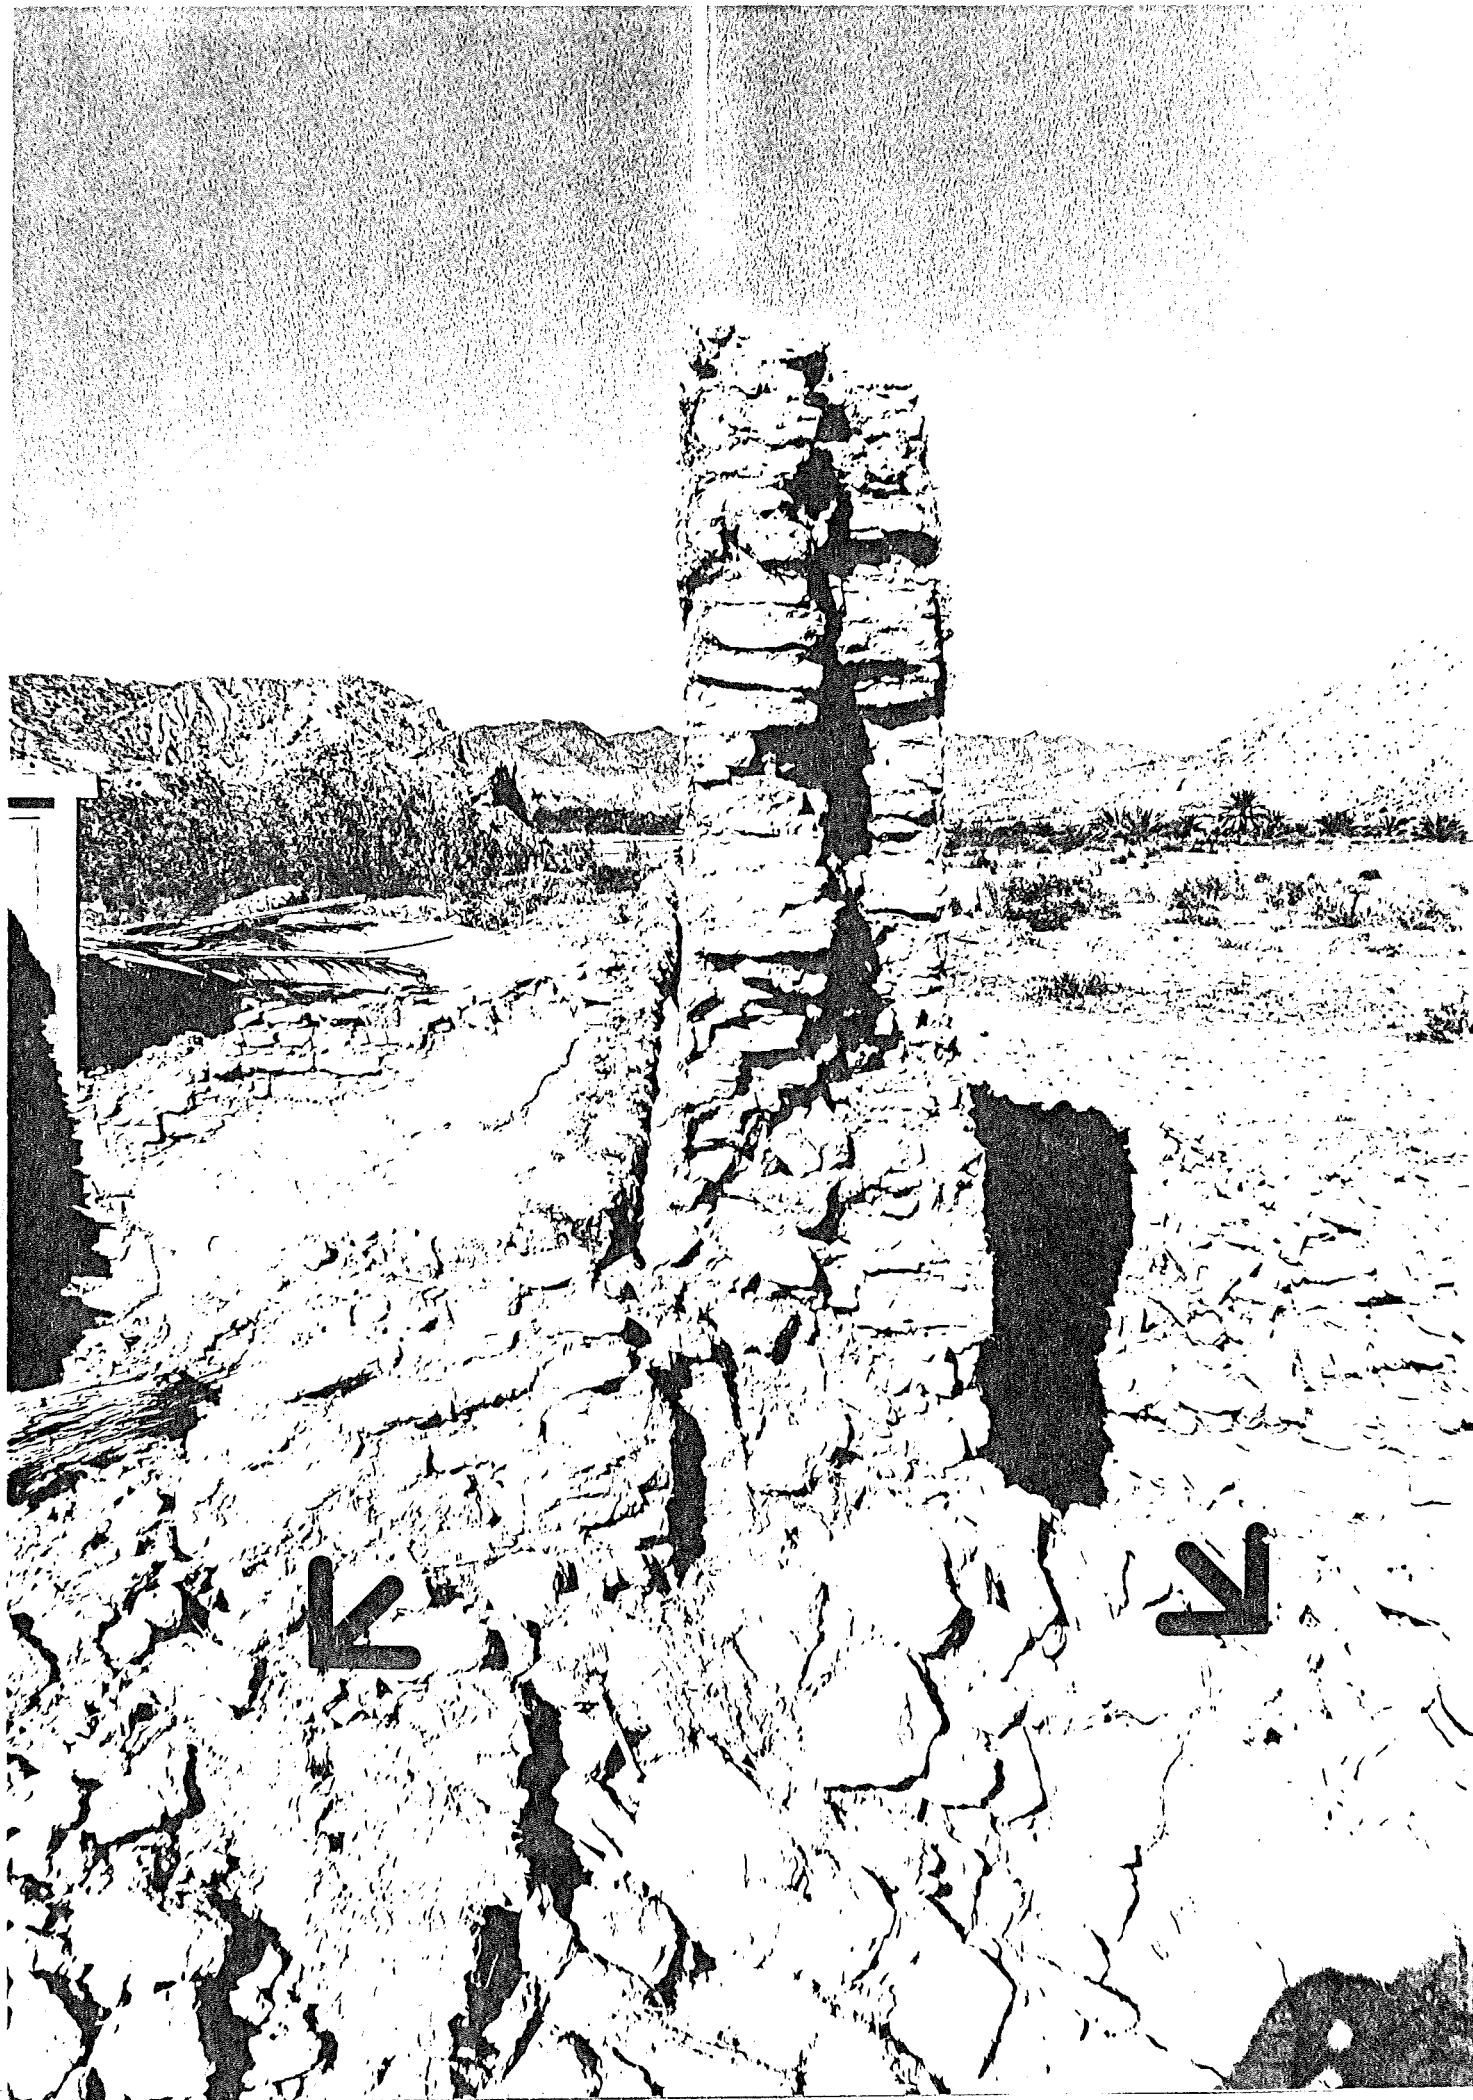
The failure of these walls was facilitated by the lack of bonding through the width of the wall. Walls were built with an outer and inner course of bricks, with only the mortar to hold the two halves together. These two halves tended to separate during the tremors, so that neither half consequently was strong enough or thick enough to stand up on its own or to support its load, leading to collapse. In the absence of observing the actual collapse of these buildings, it is not possible to state accurately which part collapsed first or exactly how; however, the lack of bonding would facilitate the total disintegration of the wall. There was also evidence that the strength of the walls had been reduced by termite bore holes, which seemed particularly the case for the mud mortar used between the bricks, which may have been prepared with less care than the mud bricks themselves. Similarly, where timber had been embedded into the walls (basically a good practice in reinforcing and framing the walls of a building for earthquake protection), it had been attacked by subterranean termites and substantially weakened. There were some instances where walls had fallen intact as a result of the movement. Examples of this were particularly apparent where existing openings had been filled in at a later date with no bond to the sides of the opening and with nothing to resist the collapse of the added wall, which in several cases was seen lying almost intact on the ground.

Examples of wall failure due to lack of internal bonding

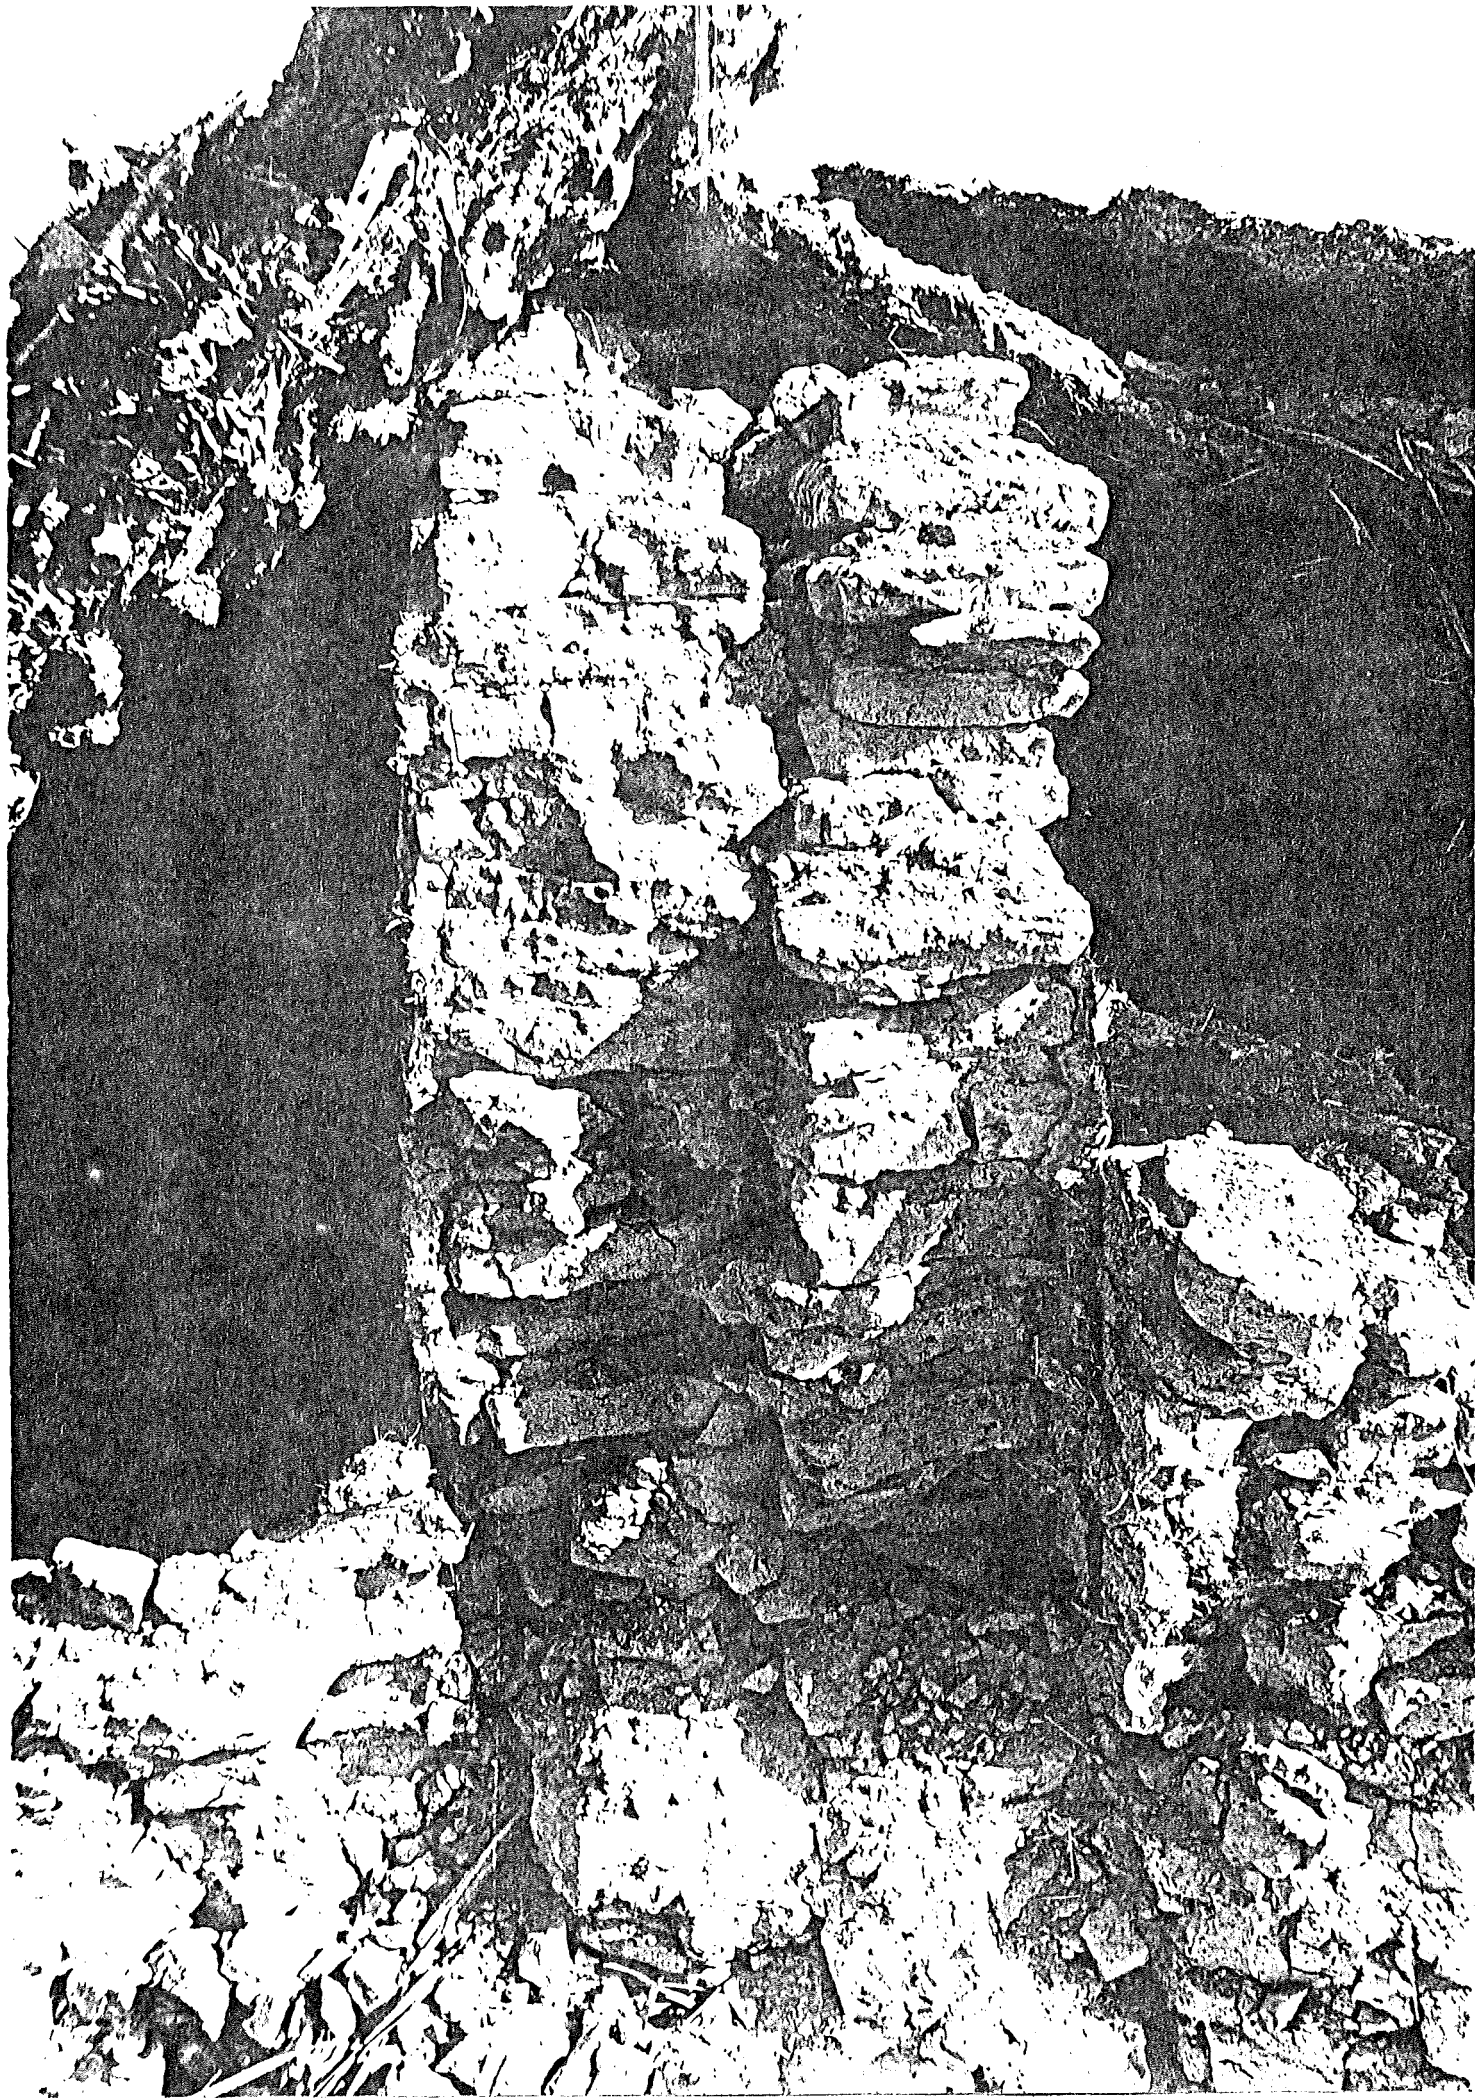
Additionally, stone walls were built with no bonding - small round stones placed on top of each other formed the two sides of the wall, with general rubble and earth filling in the gap between. In many cases the outer surface had simply peeled off. Elsewhere the two sides had separated and had both fallen away. If walls are load bearing, any such failure will cause the roof to collapse.

No bonding between  
wall and external surface

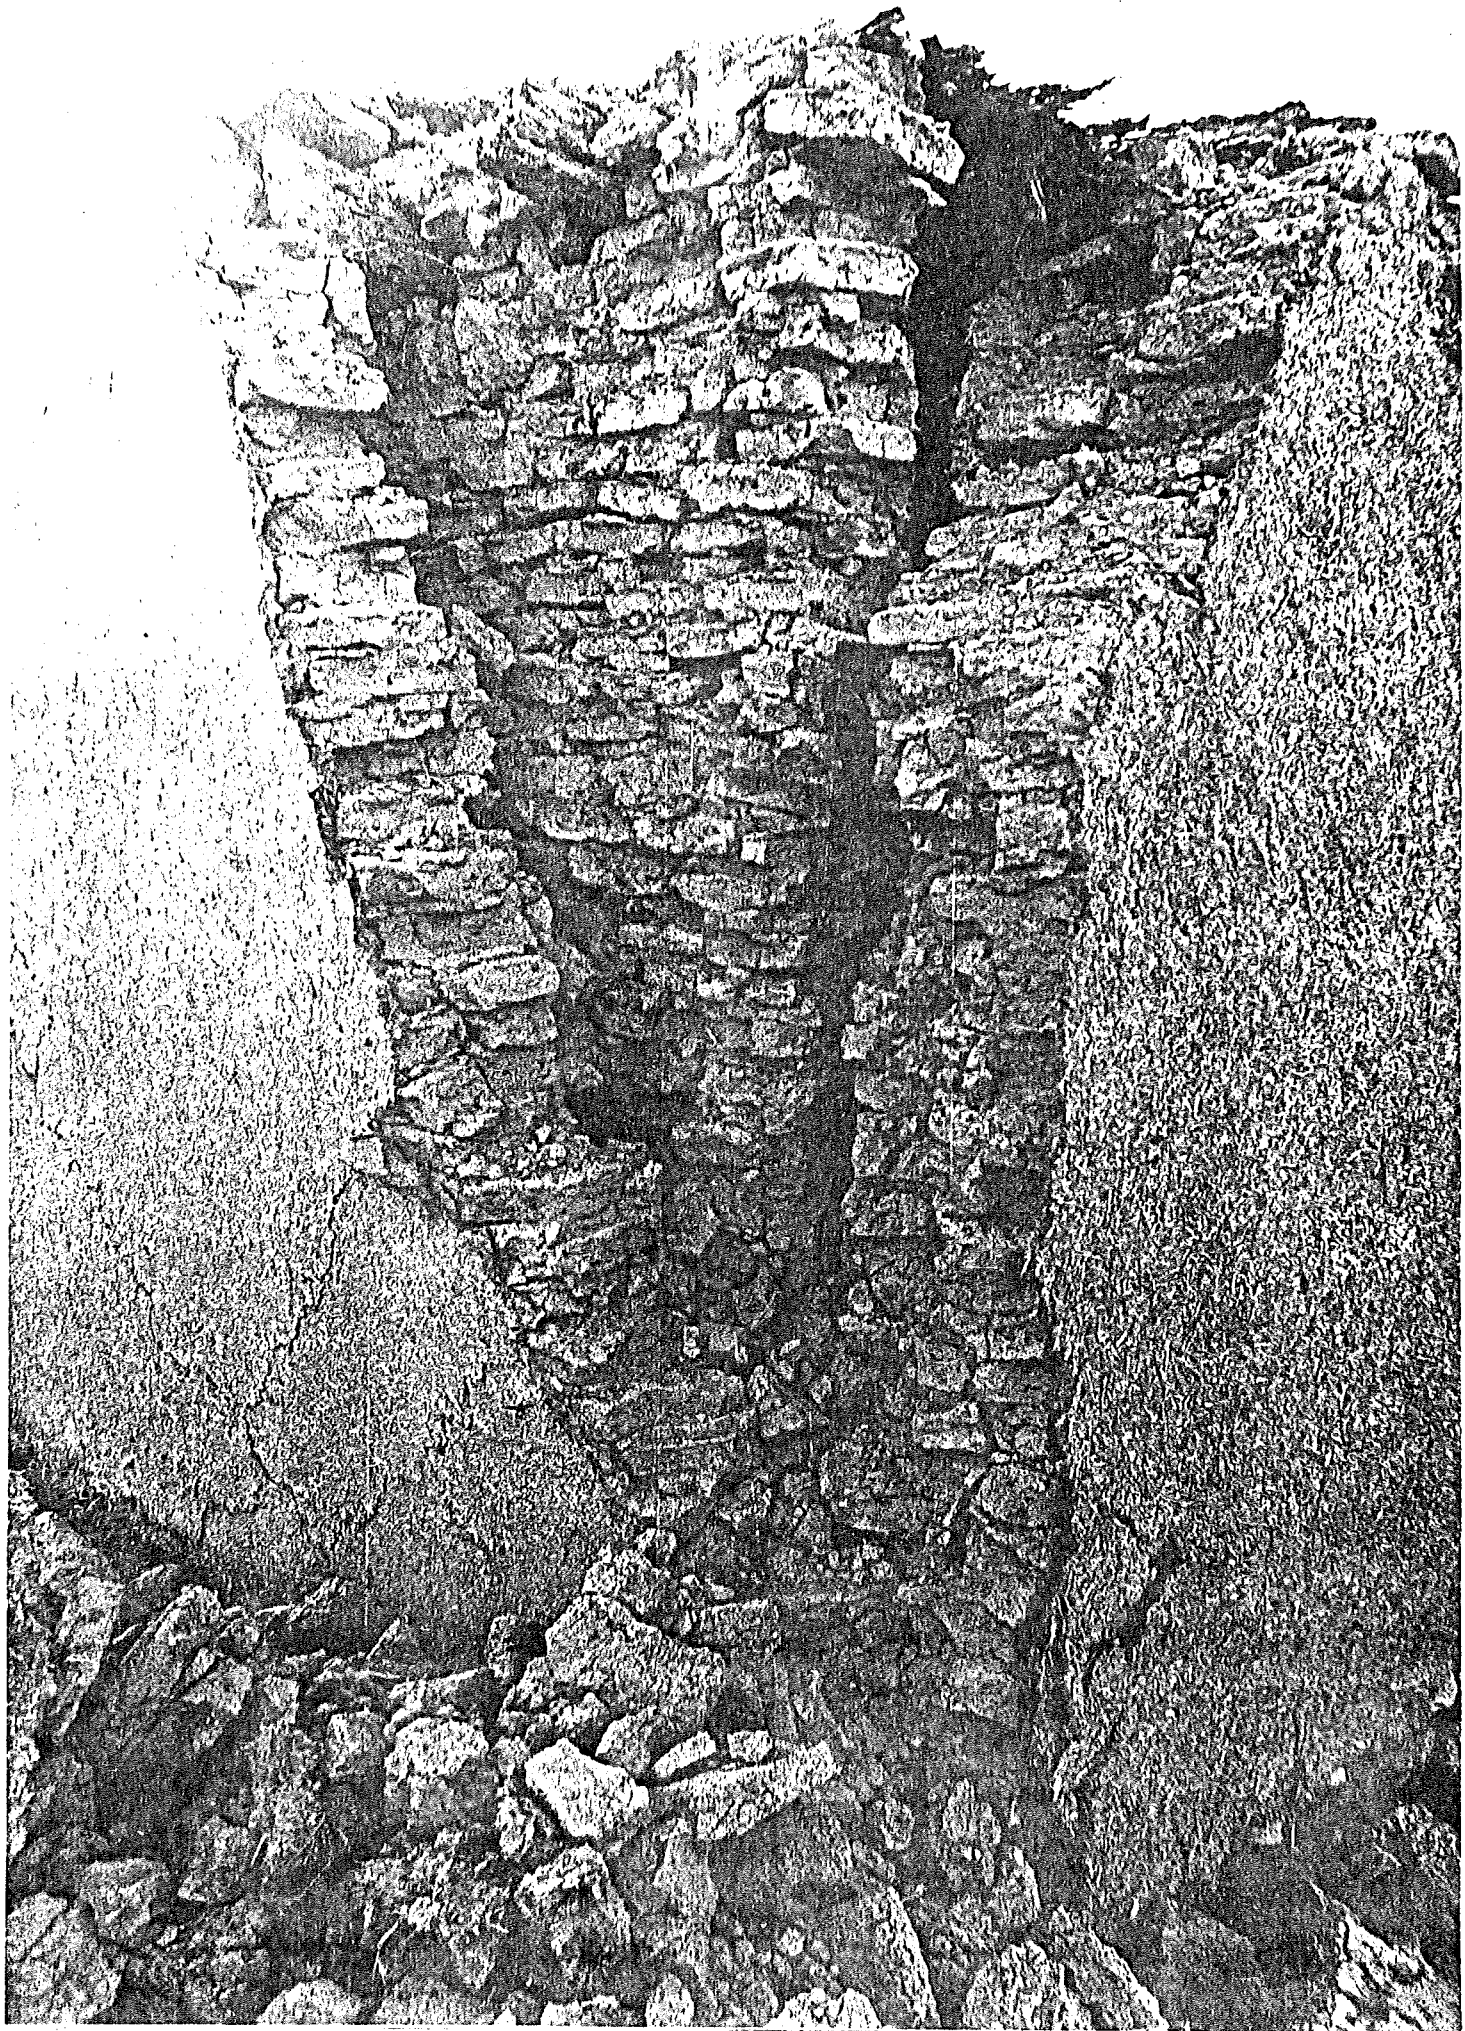
In both stone and mud wall constructions, the corners were the weakest points, and even where the building had not totally collapsed, there were severe cracks at or collapse of the corner. This is due to the weakness resulting from the two different orientations of the walls in relation to the movement of the ground, causing conflicting movement in the walls. Once again, the absence of proper bonding had increased this effect.

Examples of corner failures - due to stress concentration, poor bonding and lack of reinforcement

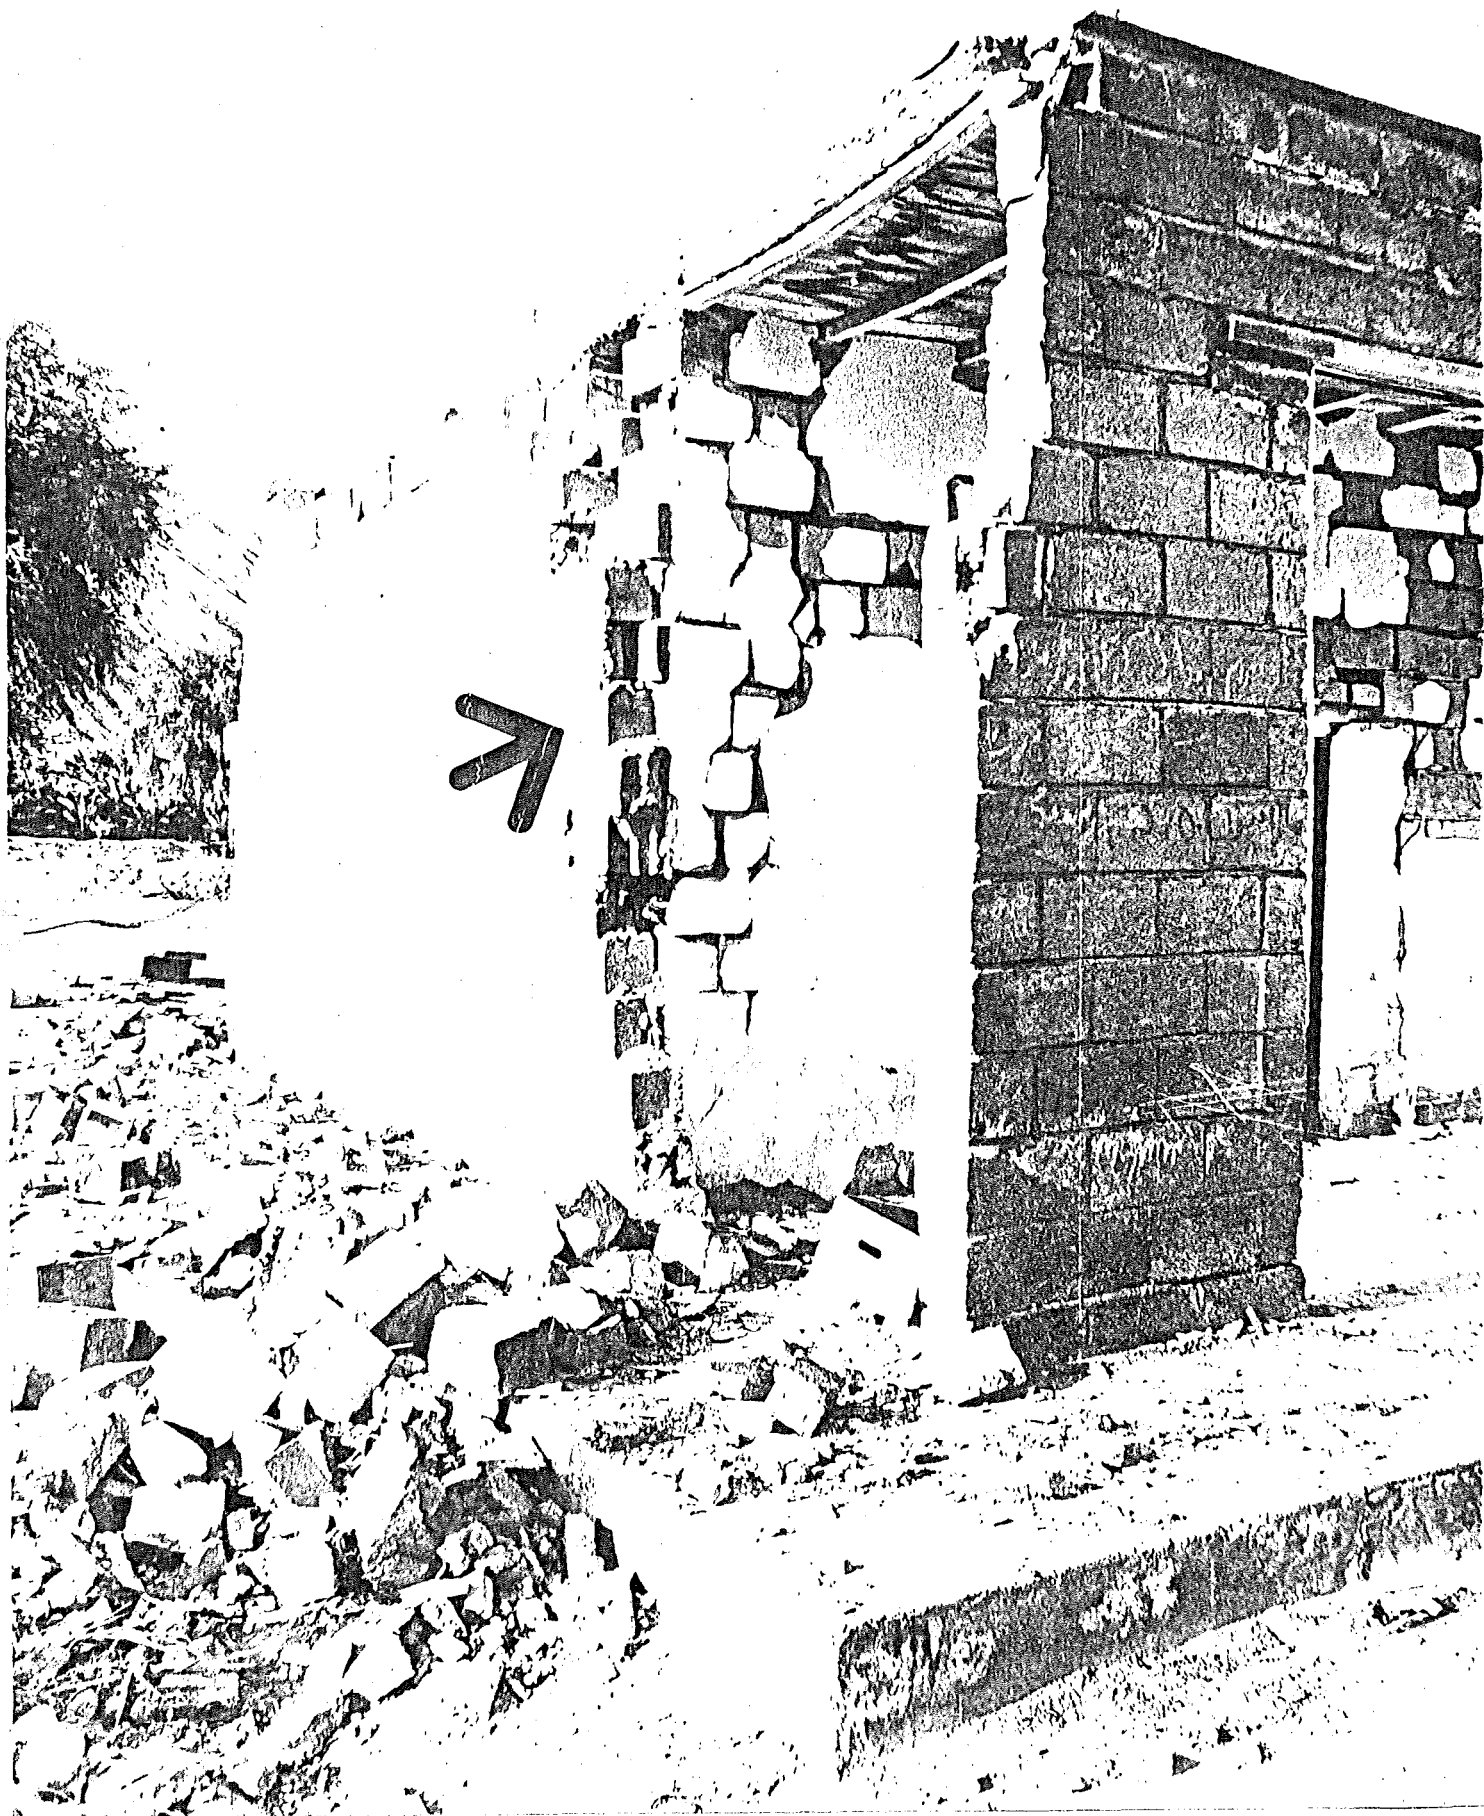
Only one building, a school, was seen during the visit that used materials and techniques not readily available in the area. The walls were of concrete block and the roof made of steel I beams with brick jack arches. There was a sheet of chicken wire mesh under the roof structure, onto which the plaster had been applied. All the walls were cracked and one of the loadbearing walls had totally collapsed. The roof had collapsed.

The steel I beams had not been tied together and overall the building had suffered from insufficient, and in parts non-existent framing. With the movement of the steel, the jack arches had also collapsed.

Corner failure  
and collapse of concrete  
black school

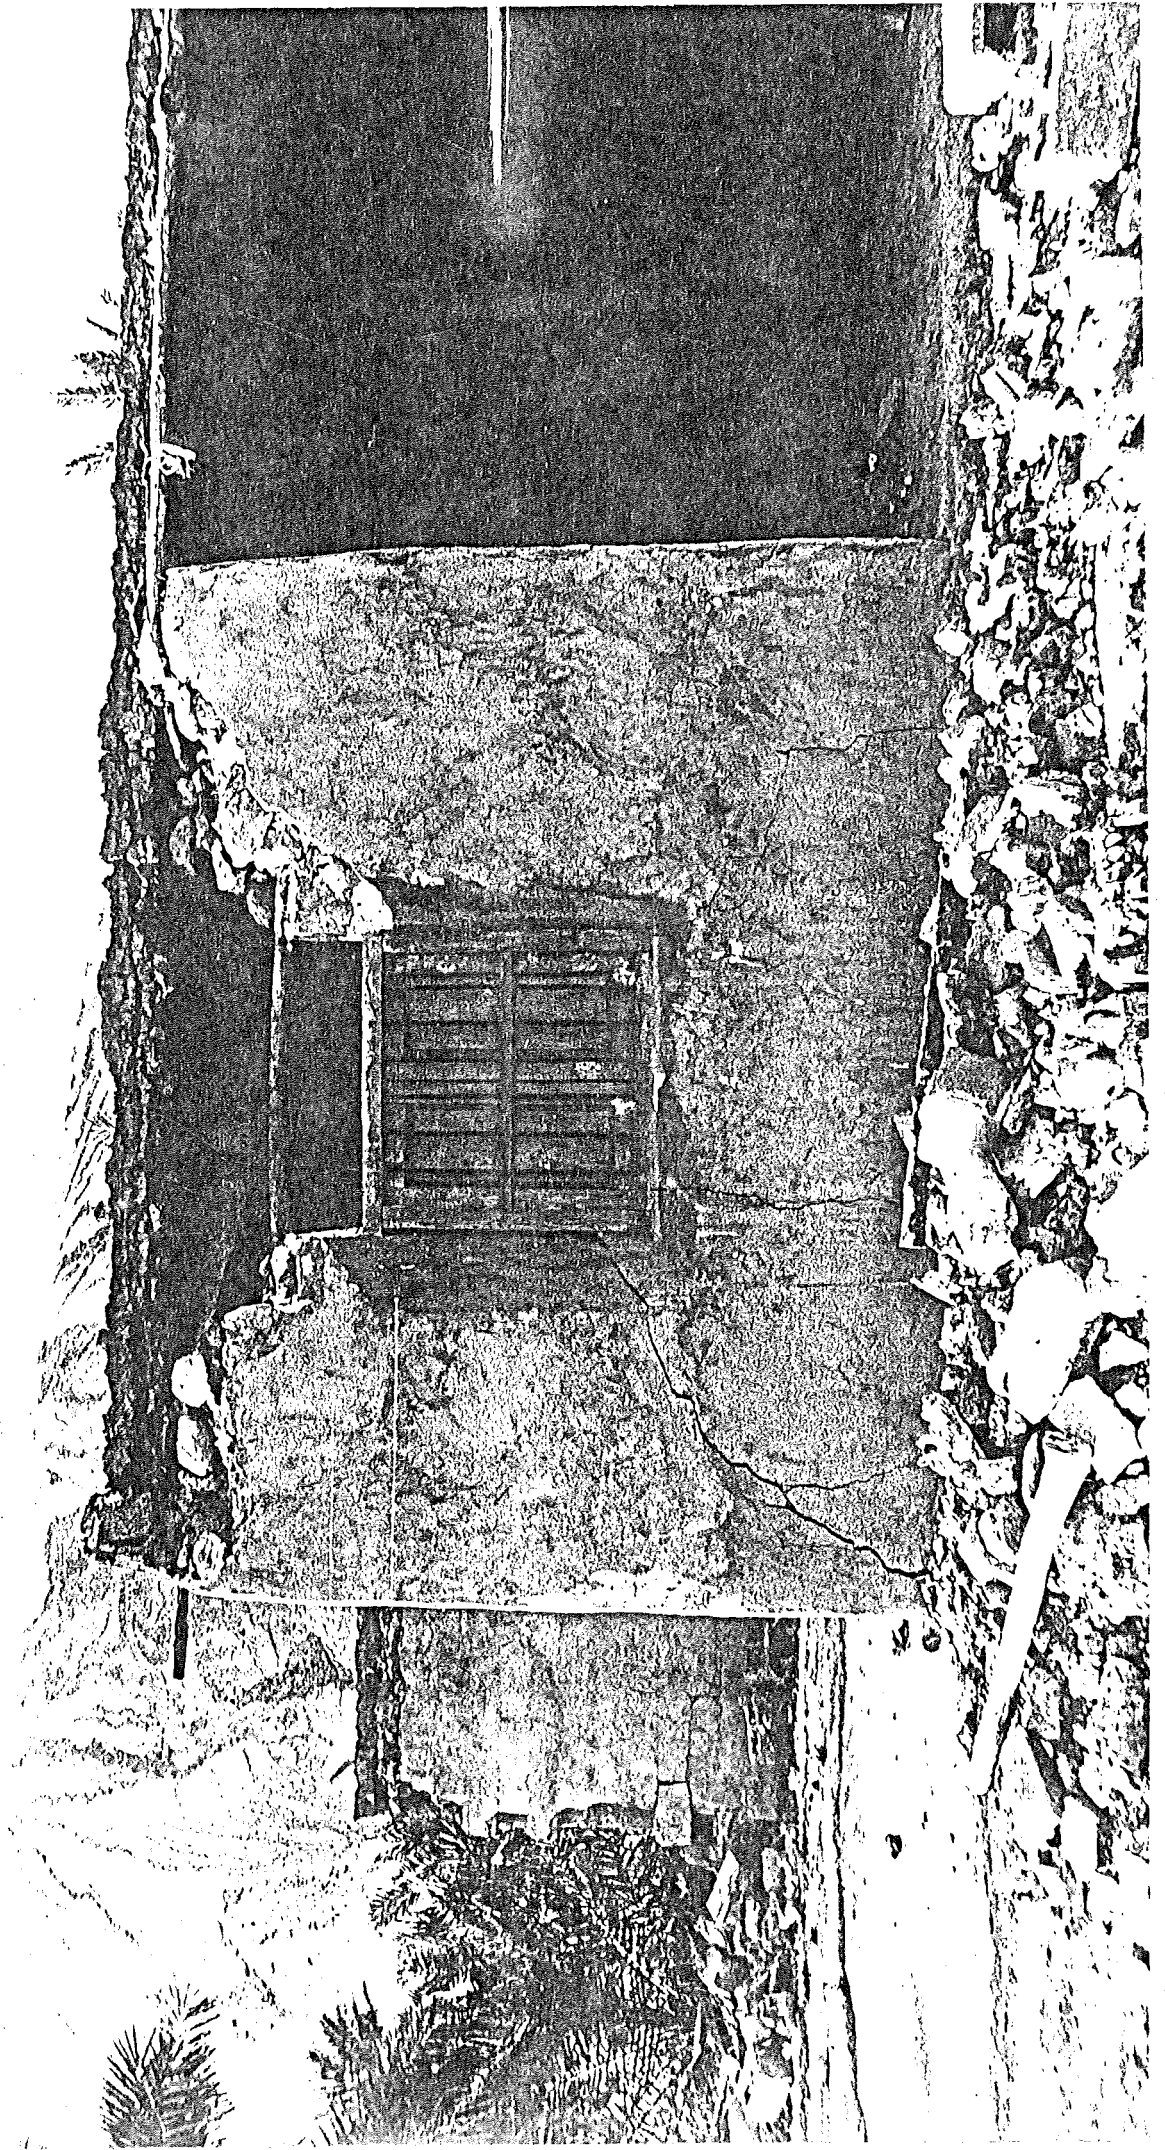
Nearly all the openings had been spanned with timber lintels. Because in most cases the lintels projected only a small amount into the wall on either side, the timber pulled out and the structure above collapsed. Even where the projection was sufficient, severe cracking on either side of the opening occurred.

Lintels over doors and windows were not embedded deep enough into walls

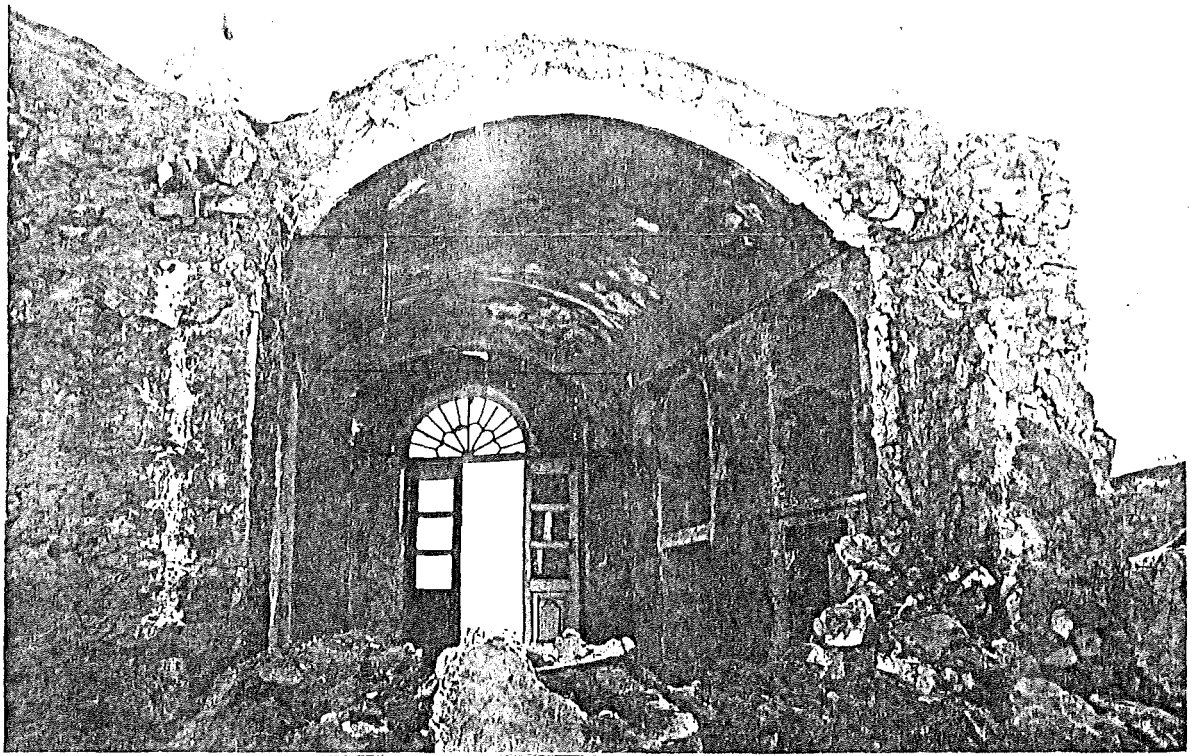
Gisk Village:

Metal tie rods anchored into reinforced horizontal beam at top of wall have prevented vault collapse. Horizontal timber beam set in cement mortar.

Detail showing timber wall reinforcing set in cement mortar.

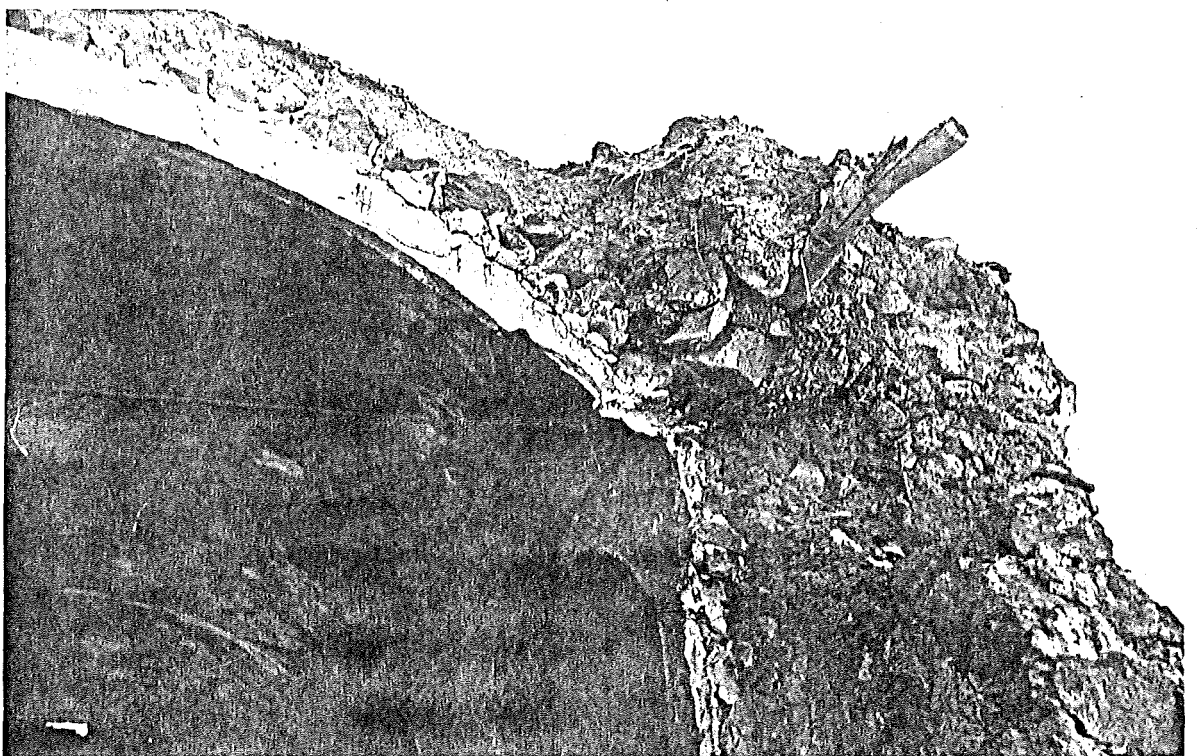
Dar Tang Gol:  
Rubble wall failure due to lack  
of internal bonding.

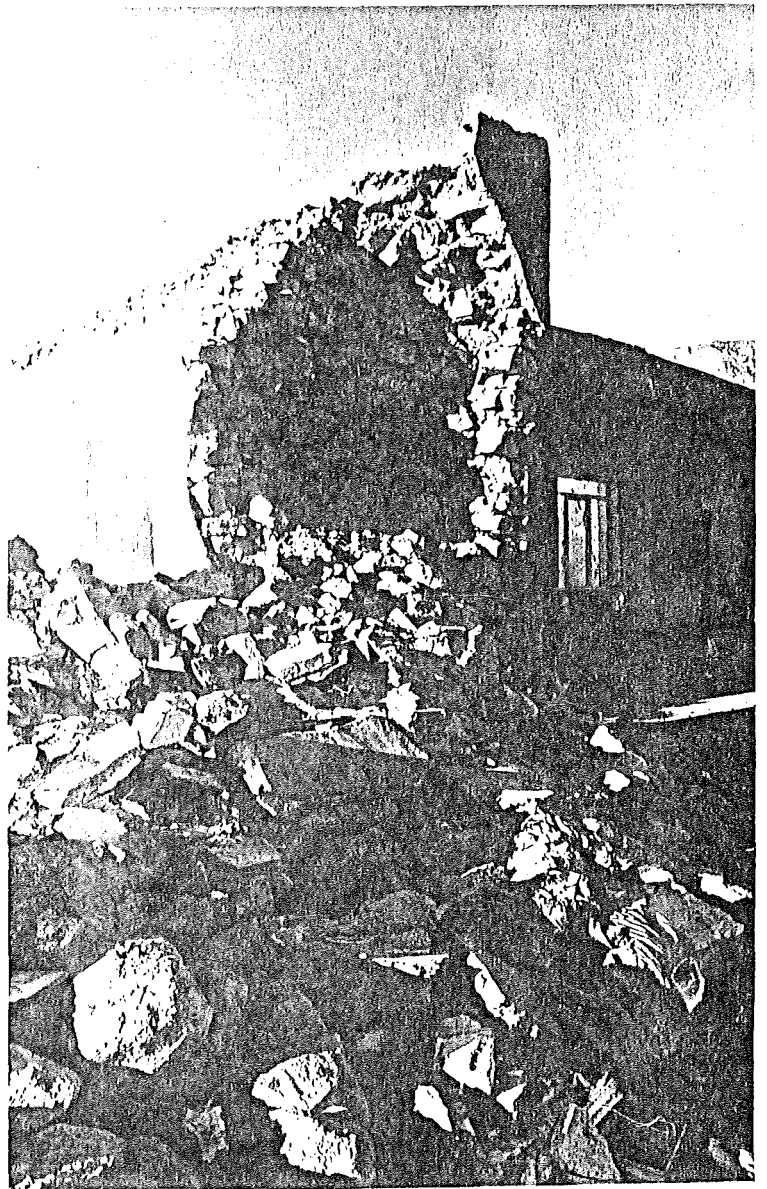
Sar Bagh:  
Corner failure due to stress  
concentration.

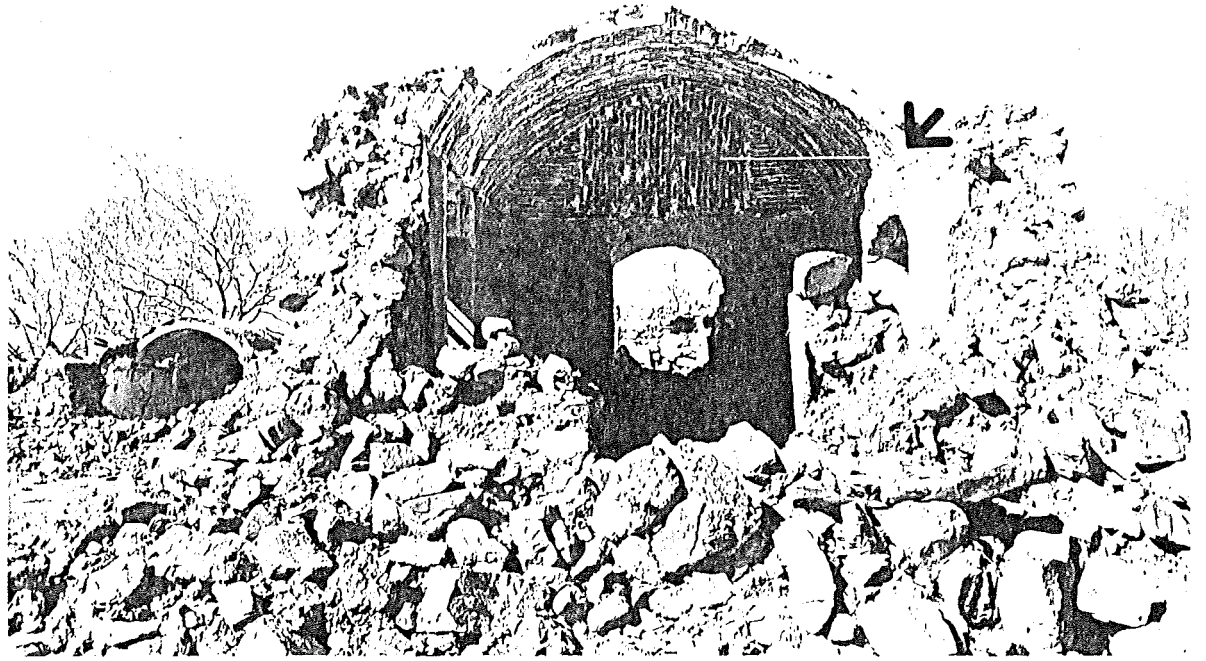
Sar Bagh Village:

Brick vault collapse. Note metal tie rods are not anchored by continuous horizontal wall ties.

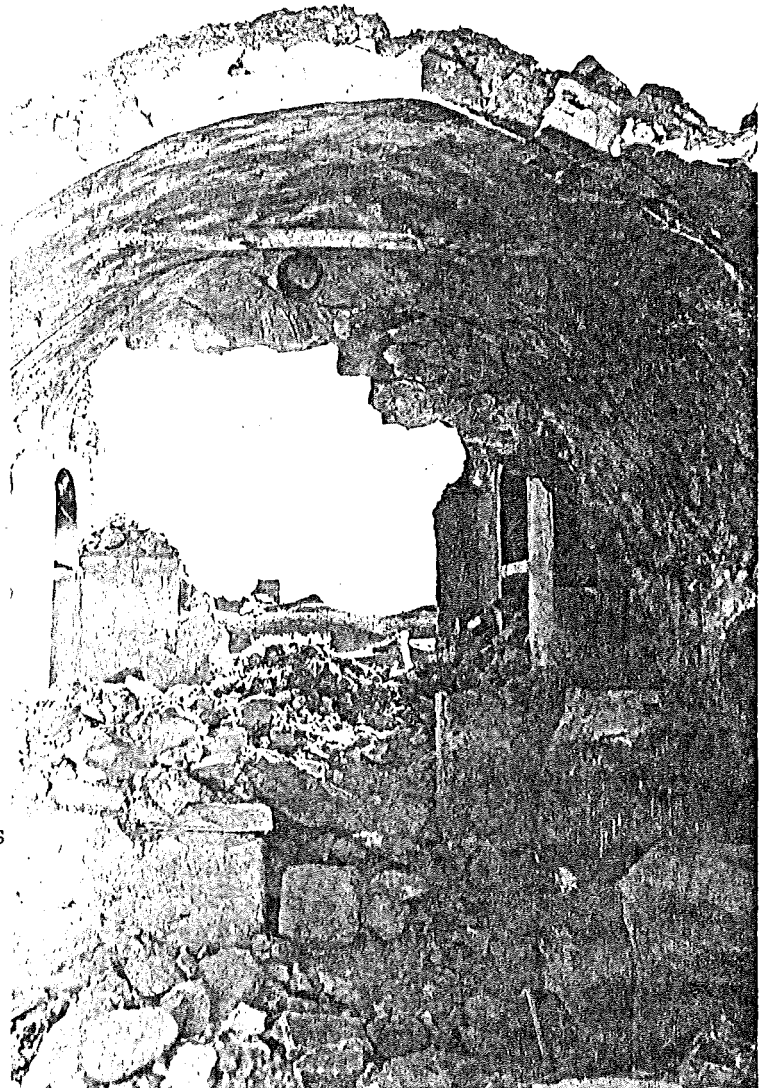
Sar Bagh:

This system of construction creates a very heavy roof, undesirable in earthquake areas. The stones are held together merely by the mortar, and the lack of bonding between them causes collapse in the event of earthquake movement. Hence the structure of the roof depends solely on the strength of the gypsum. The smooth edge of the arched ribs are not tied to the stone infill and therefore, as it was often the case, the vaults had sheared and collapsed at the junction of the ribs and the stone infill.

Stone vaults with gypsym ribs at approximately 1 metre centres

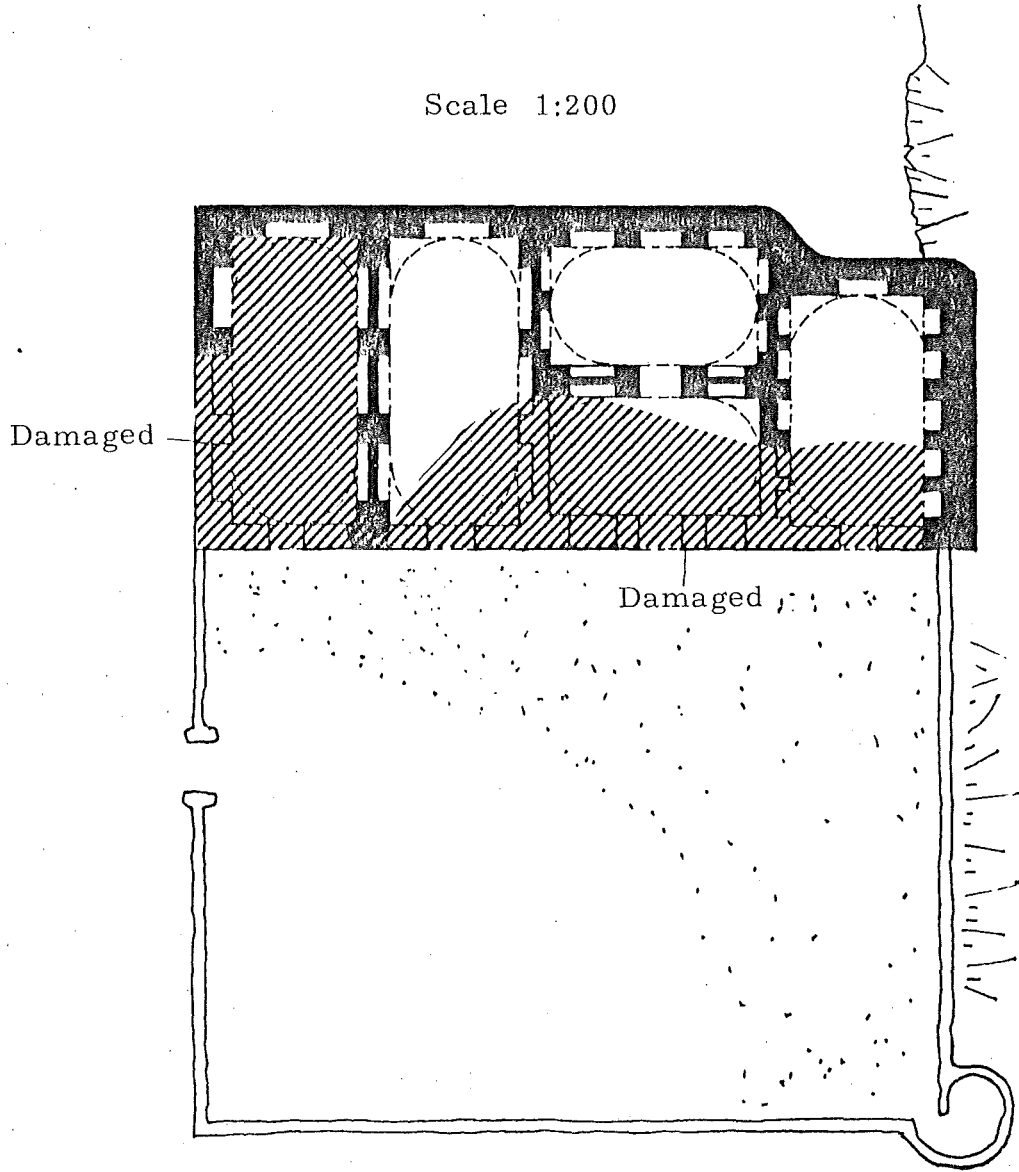
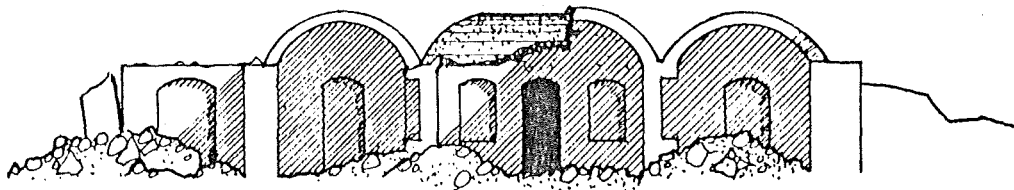
# HOUSE AT SAR BAGH VILLAGE

Built of rubble stone walls with mud mortar and stone roof vaults with gypsum mortar. Total collapse of end room and major damage to other rooms

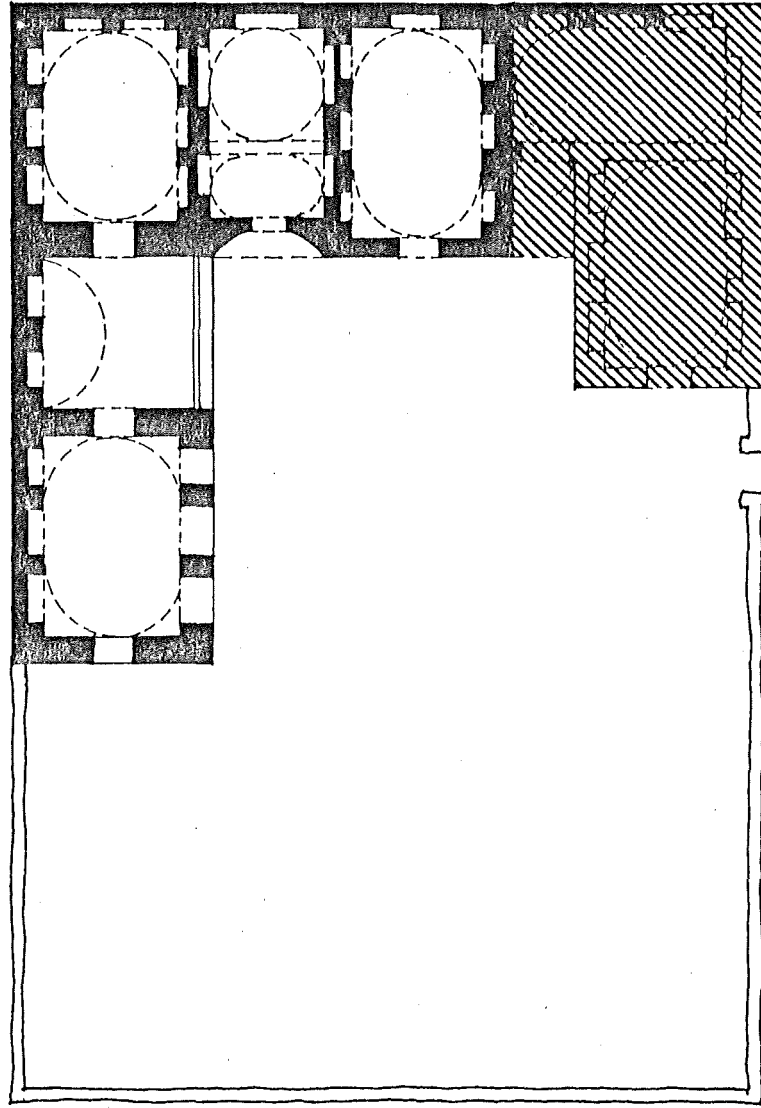
HOUSE AT SAR BAGH VILLAGE

Stone and mud construction.  
Stress concentration in end rooms  
caused collapse.
