A STRATEGY FOR DEVELOPING  
INDIGENOUS BUILDING IN  
EARTHQUAKE REGIONS

CASE STUDIES OF THE BANDAR ABBAS 1977 EARTHQUAKE  
AND THE ZARAND 1978 EARTHQUAKE

BY  
DEVELOPMENT WORKSHOP

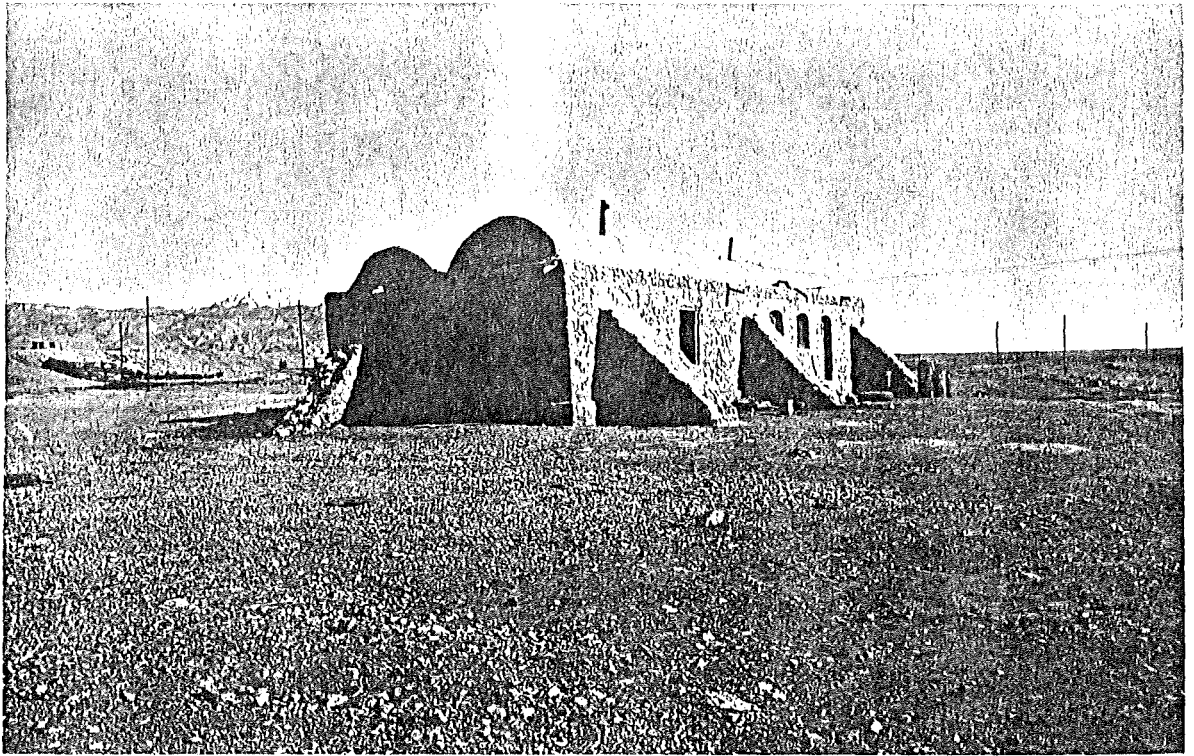
Workshop building south of Sar Bagh.  
(See accompanying drawing).

Stone walls in lime mortar and fired brick vaults. External buttresses assisted building to withstand major earthquake damage.

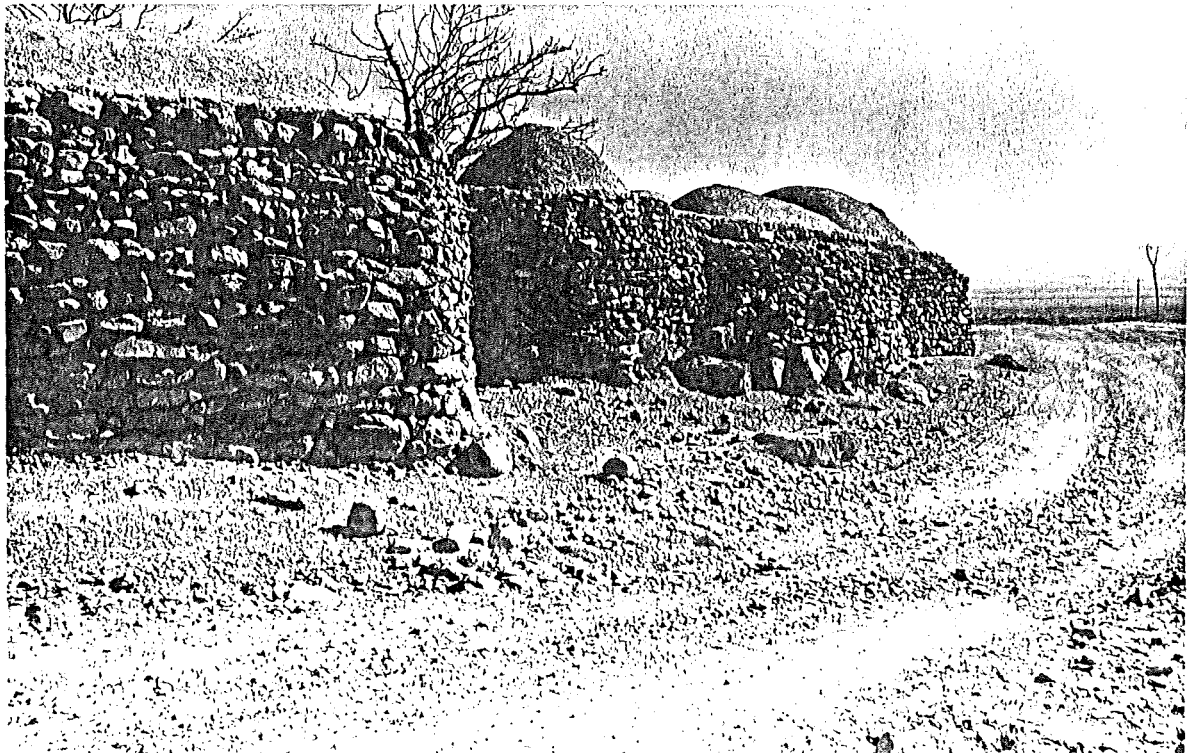
House south of Sar Bagh:  
Rounded corners tend to disperse  
load which would otherwise be  
concentrated and cause damage.

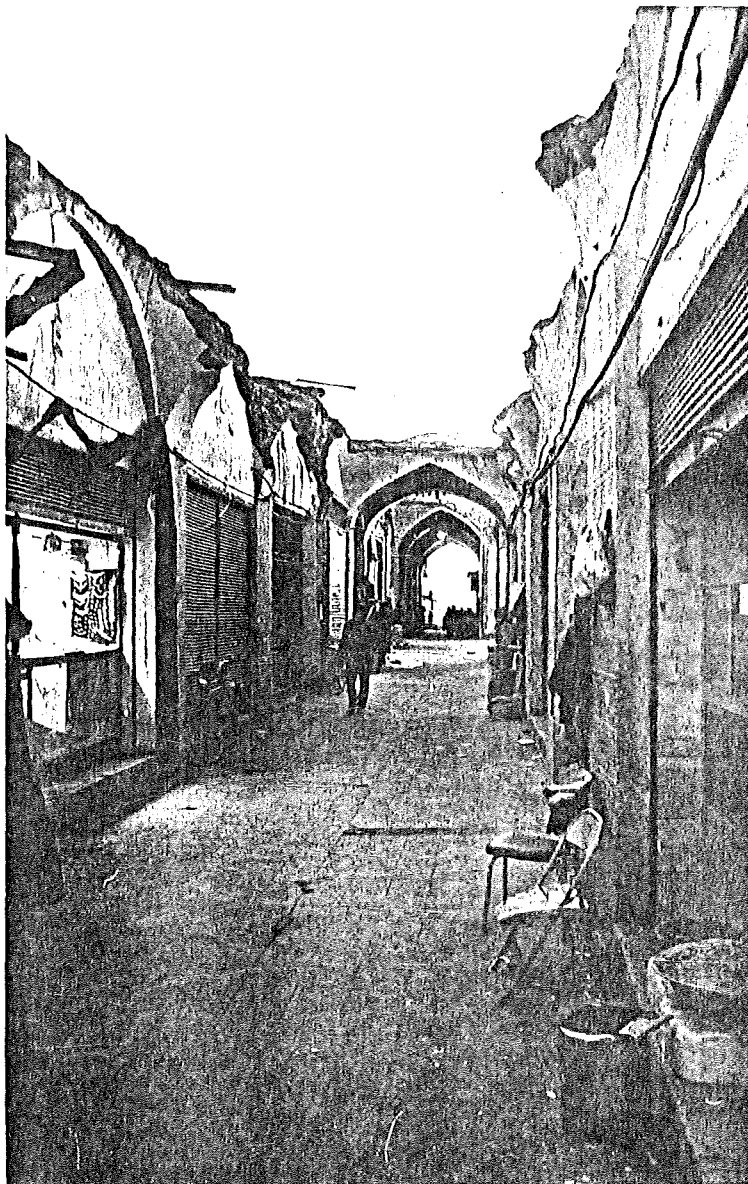
**1**

Zarand - Bazaar;

Collapse of bazaar roof probably due to poor repair.

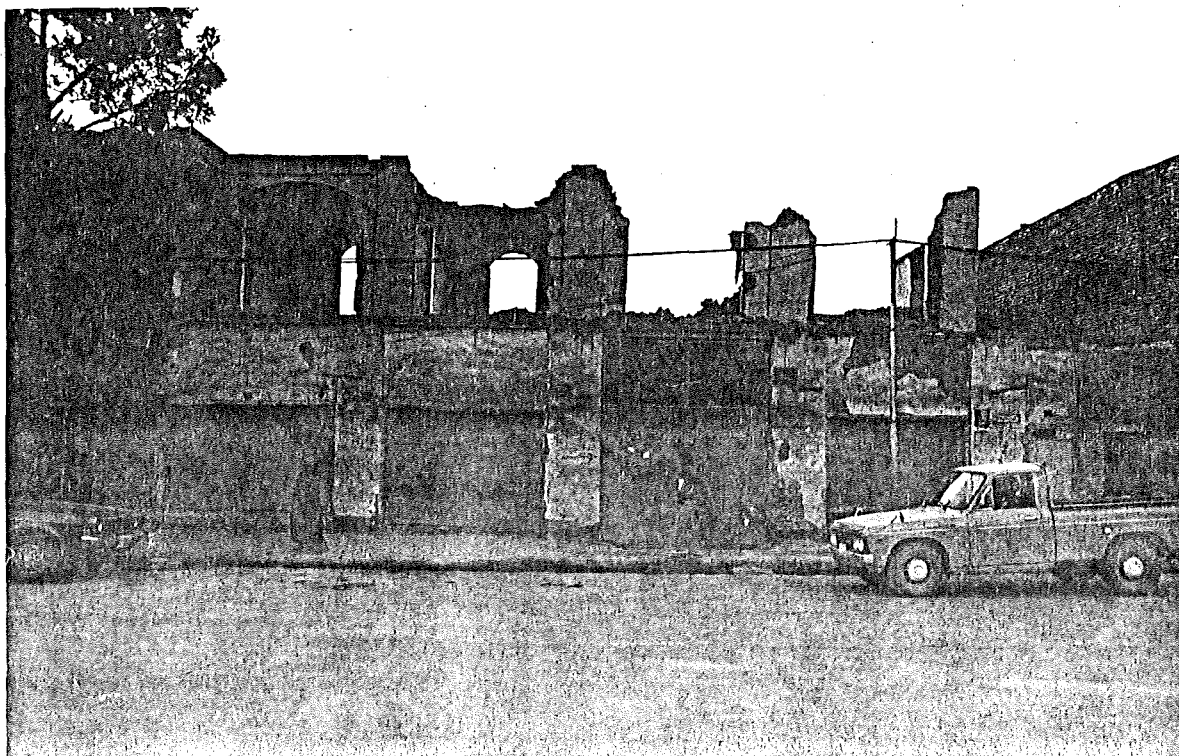
**2** Zarand -

Vaults built side by side show progressively greater damage toward ends.

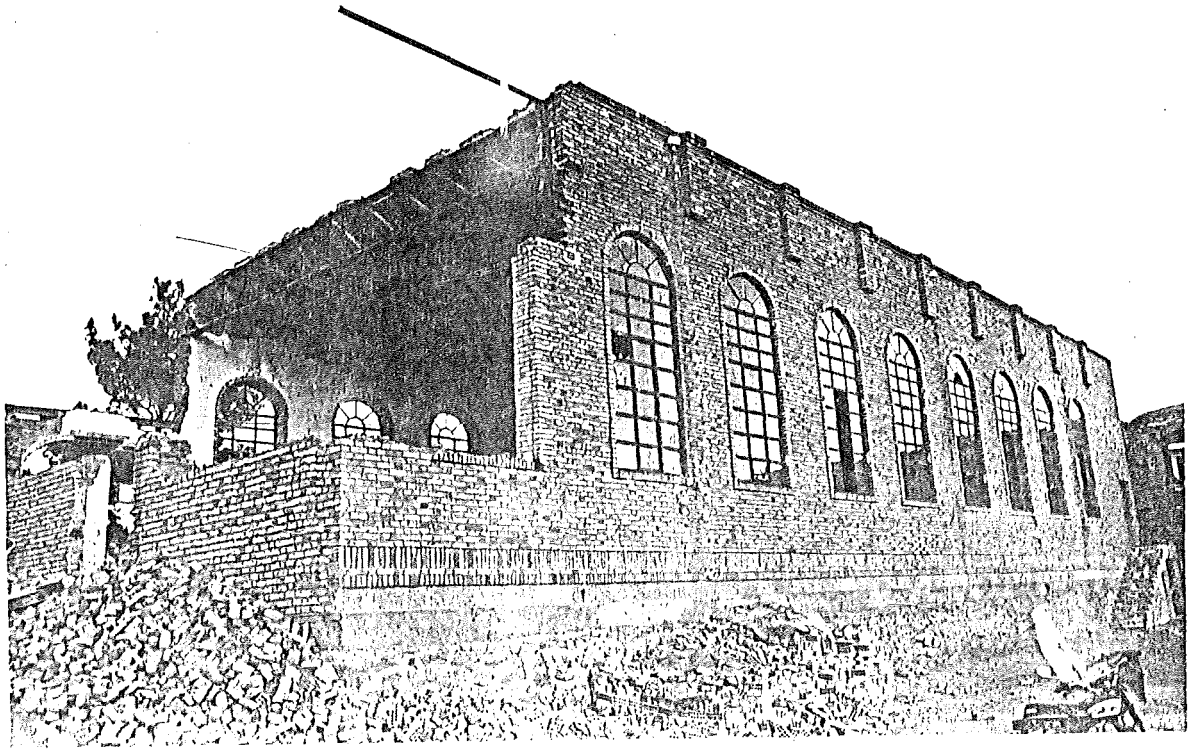
**3** Zarand:

Recently built school failure due to improper steel framing, especially at corners.

Roof constructed of steel I beams and brick, supported by trusses.

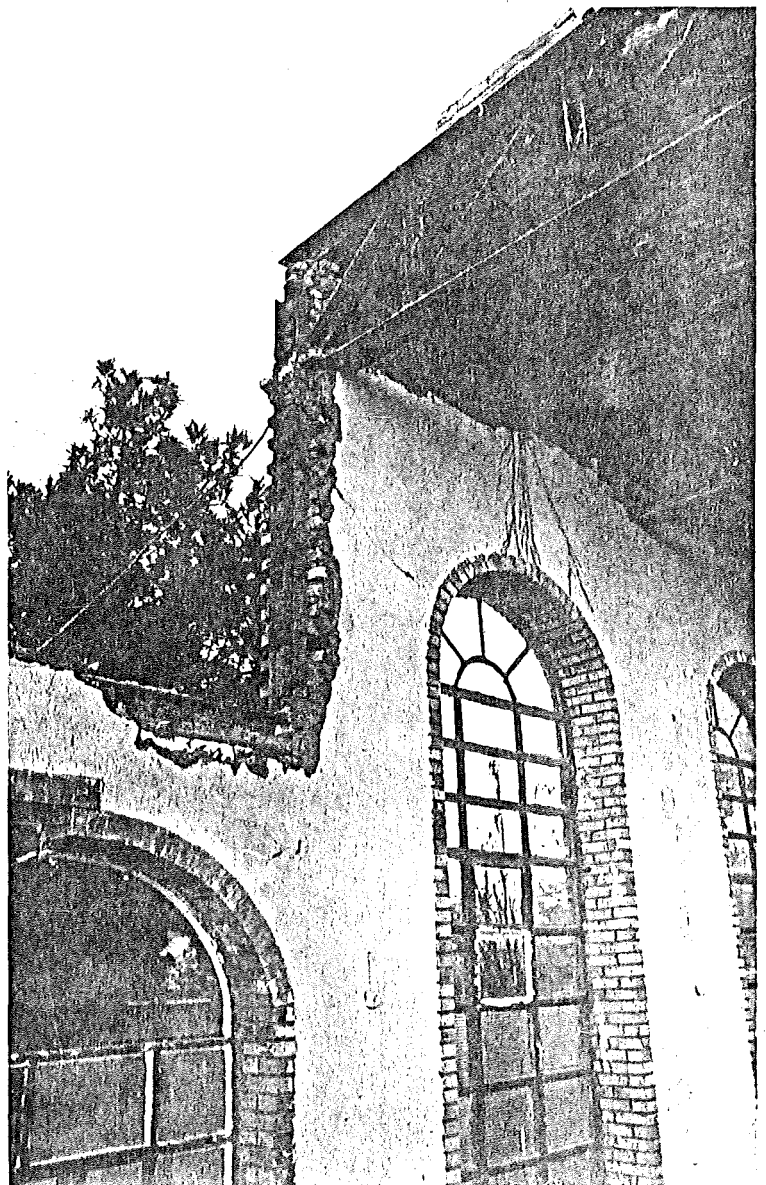
Detail of corners showing lack of steel framing.
