Indigenous Rural Housing in Muladah

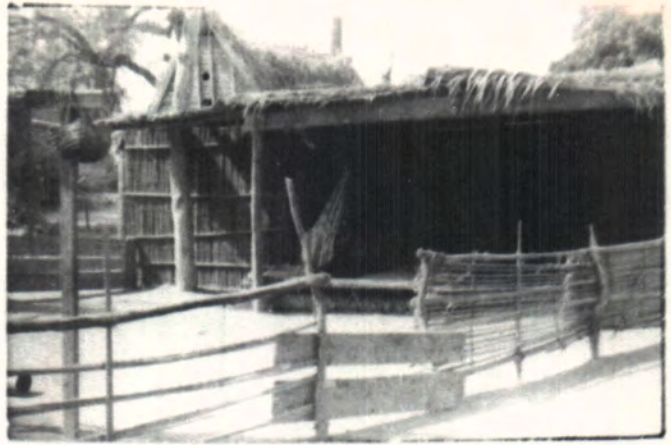
Fig 3.14

Barasti house at Om El Boche showing addition of barasti screen for winter conditions.
a. before addition
b. after addition

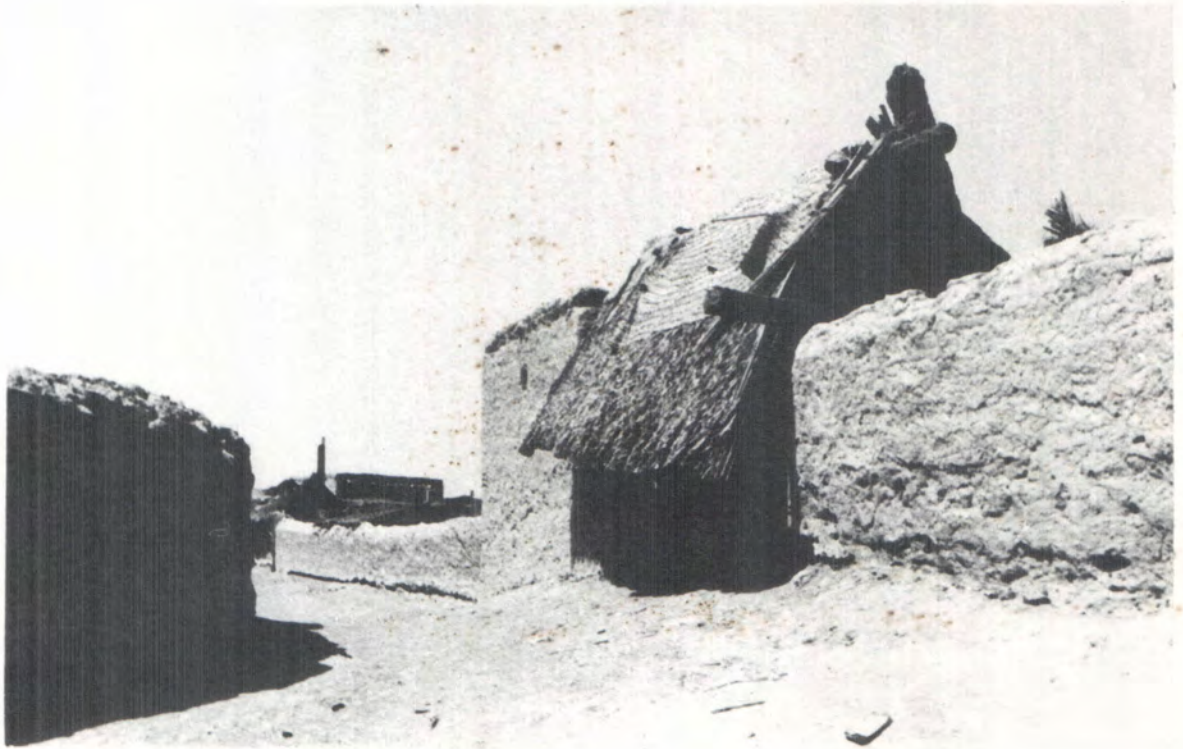
Fig 3.15 House at Maladah showing different rooms used for different seasons

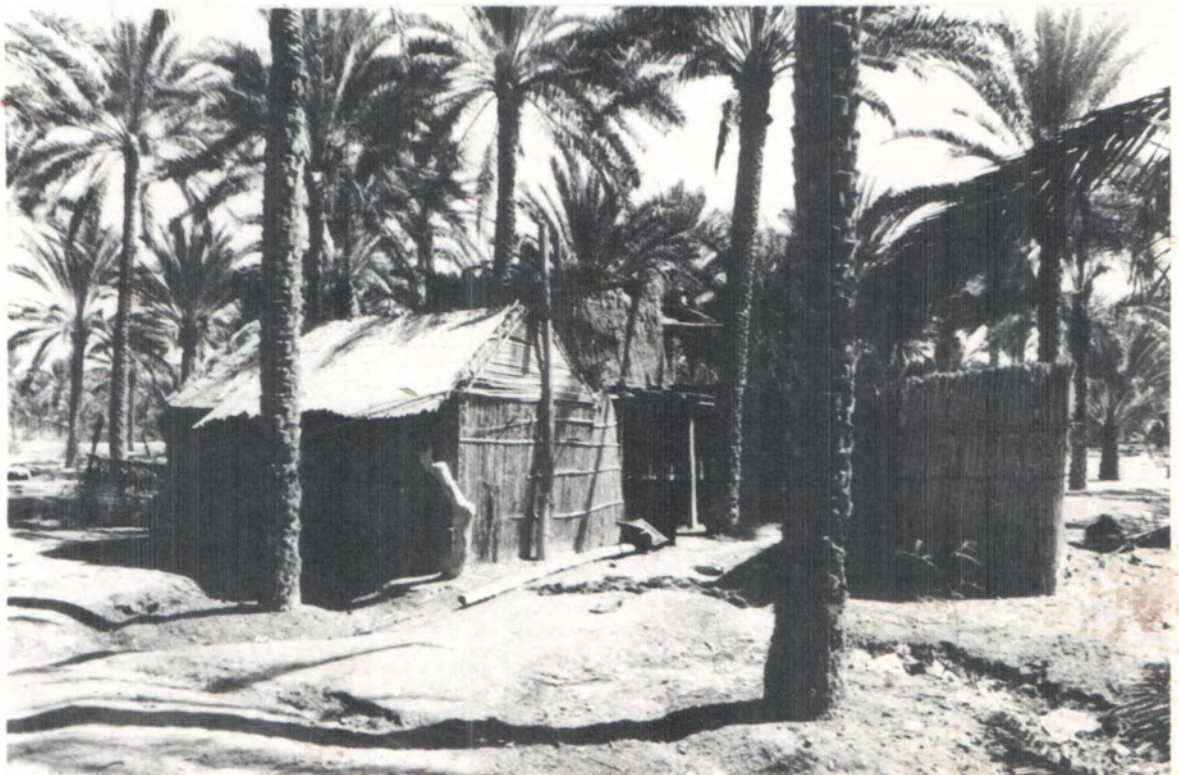
Fig 3.19 Winter Village Falaj al Qabael
Note mud brick houses and added matting on barasti roof.

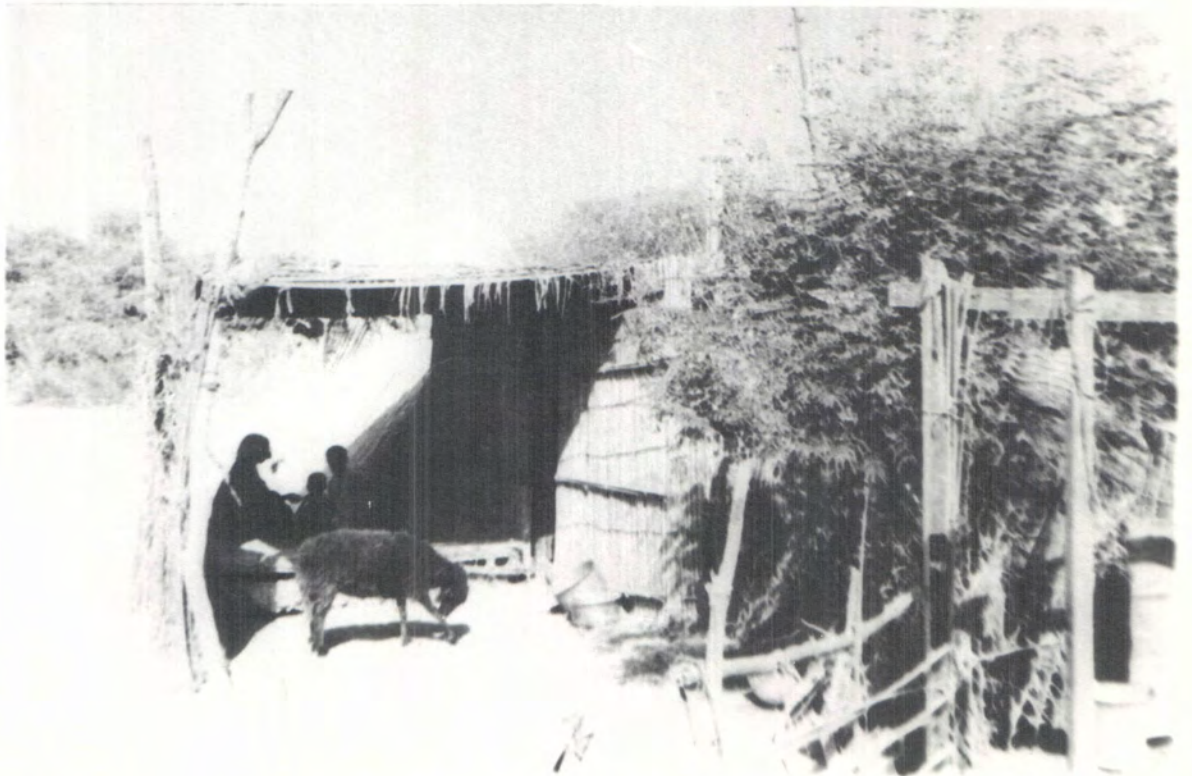
Fig 3-21

Section of barasti house showing shelter allowing free air movement through it.

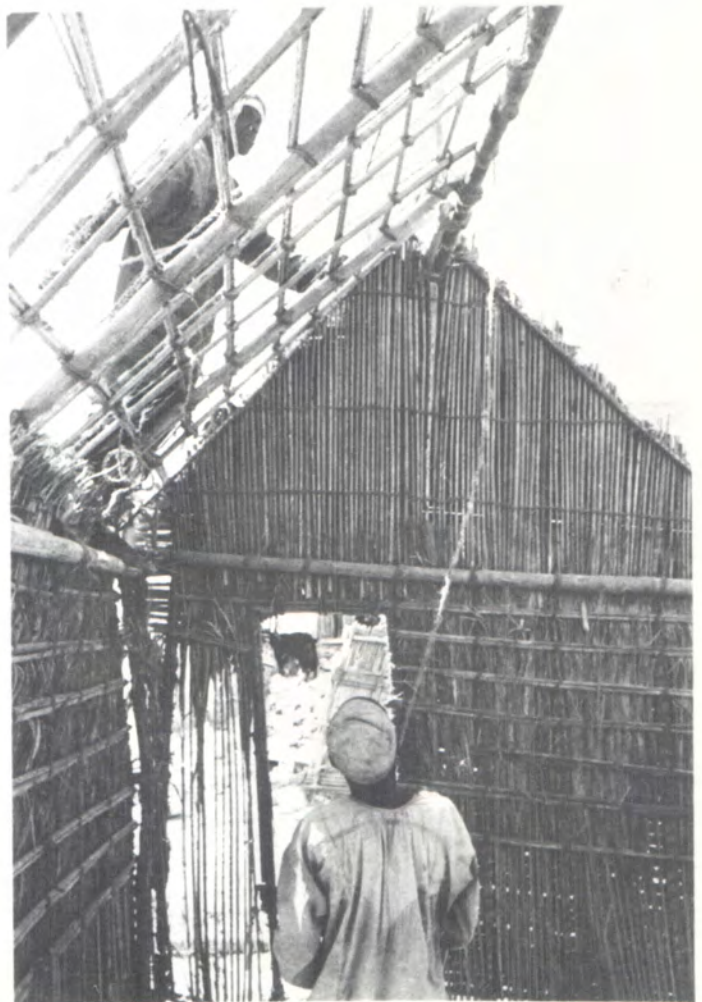
Fig. 834
The basic roof structure
is pre assembled
on the ground

Fig. 835
The roof is post tensioned
and tied when in place

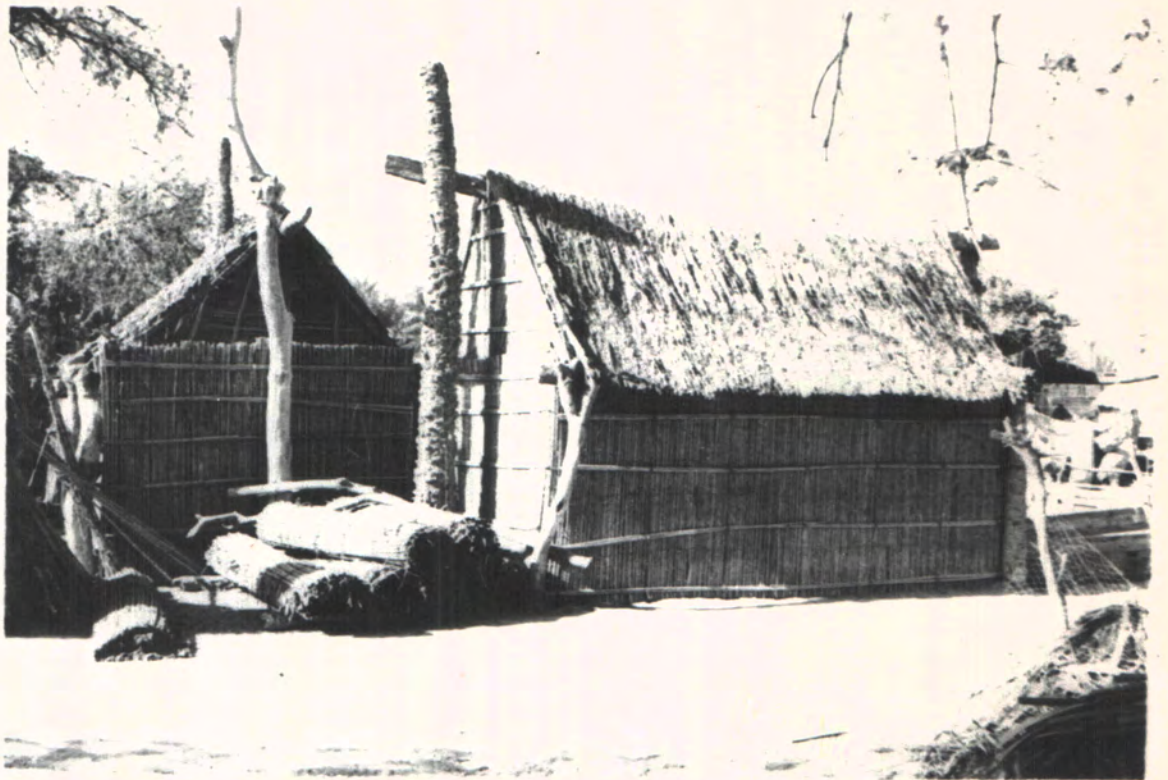
Exterior view of pitched roof rooms [Kargeen]

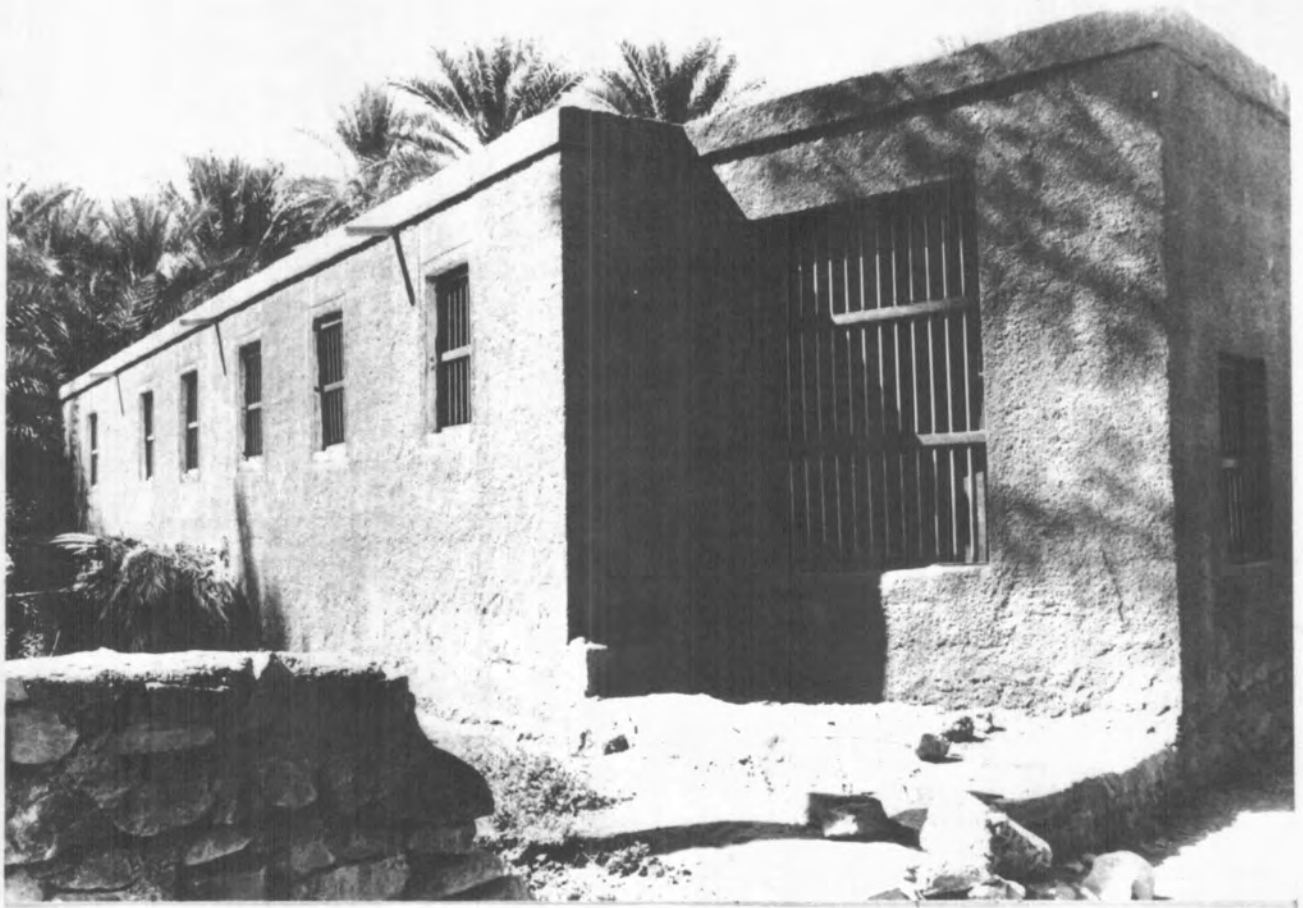
Fig.408 Recently built concrete block house, in the indigenous form.

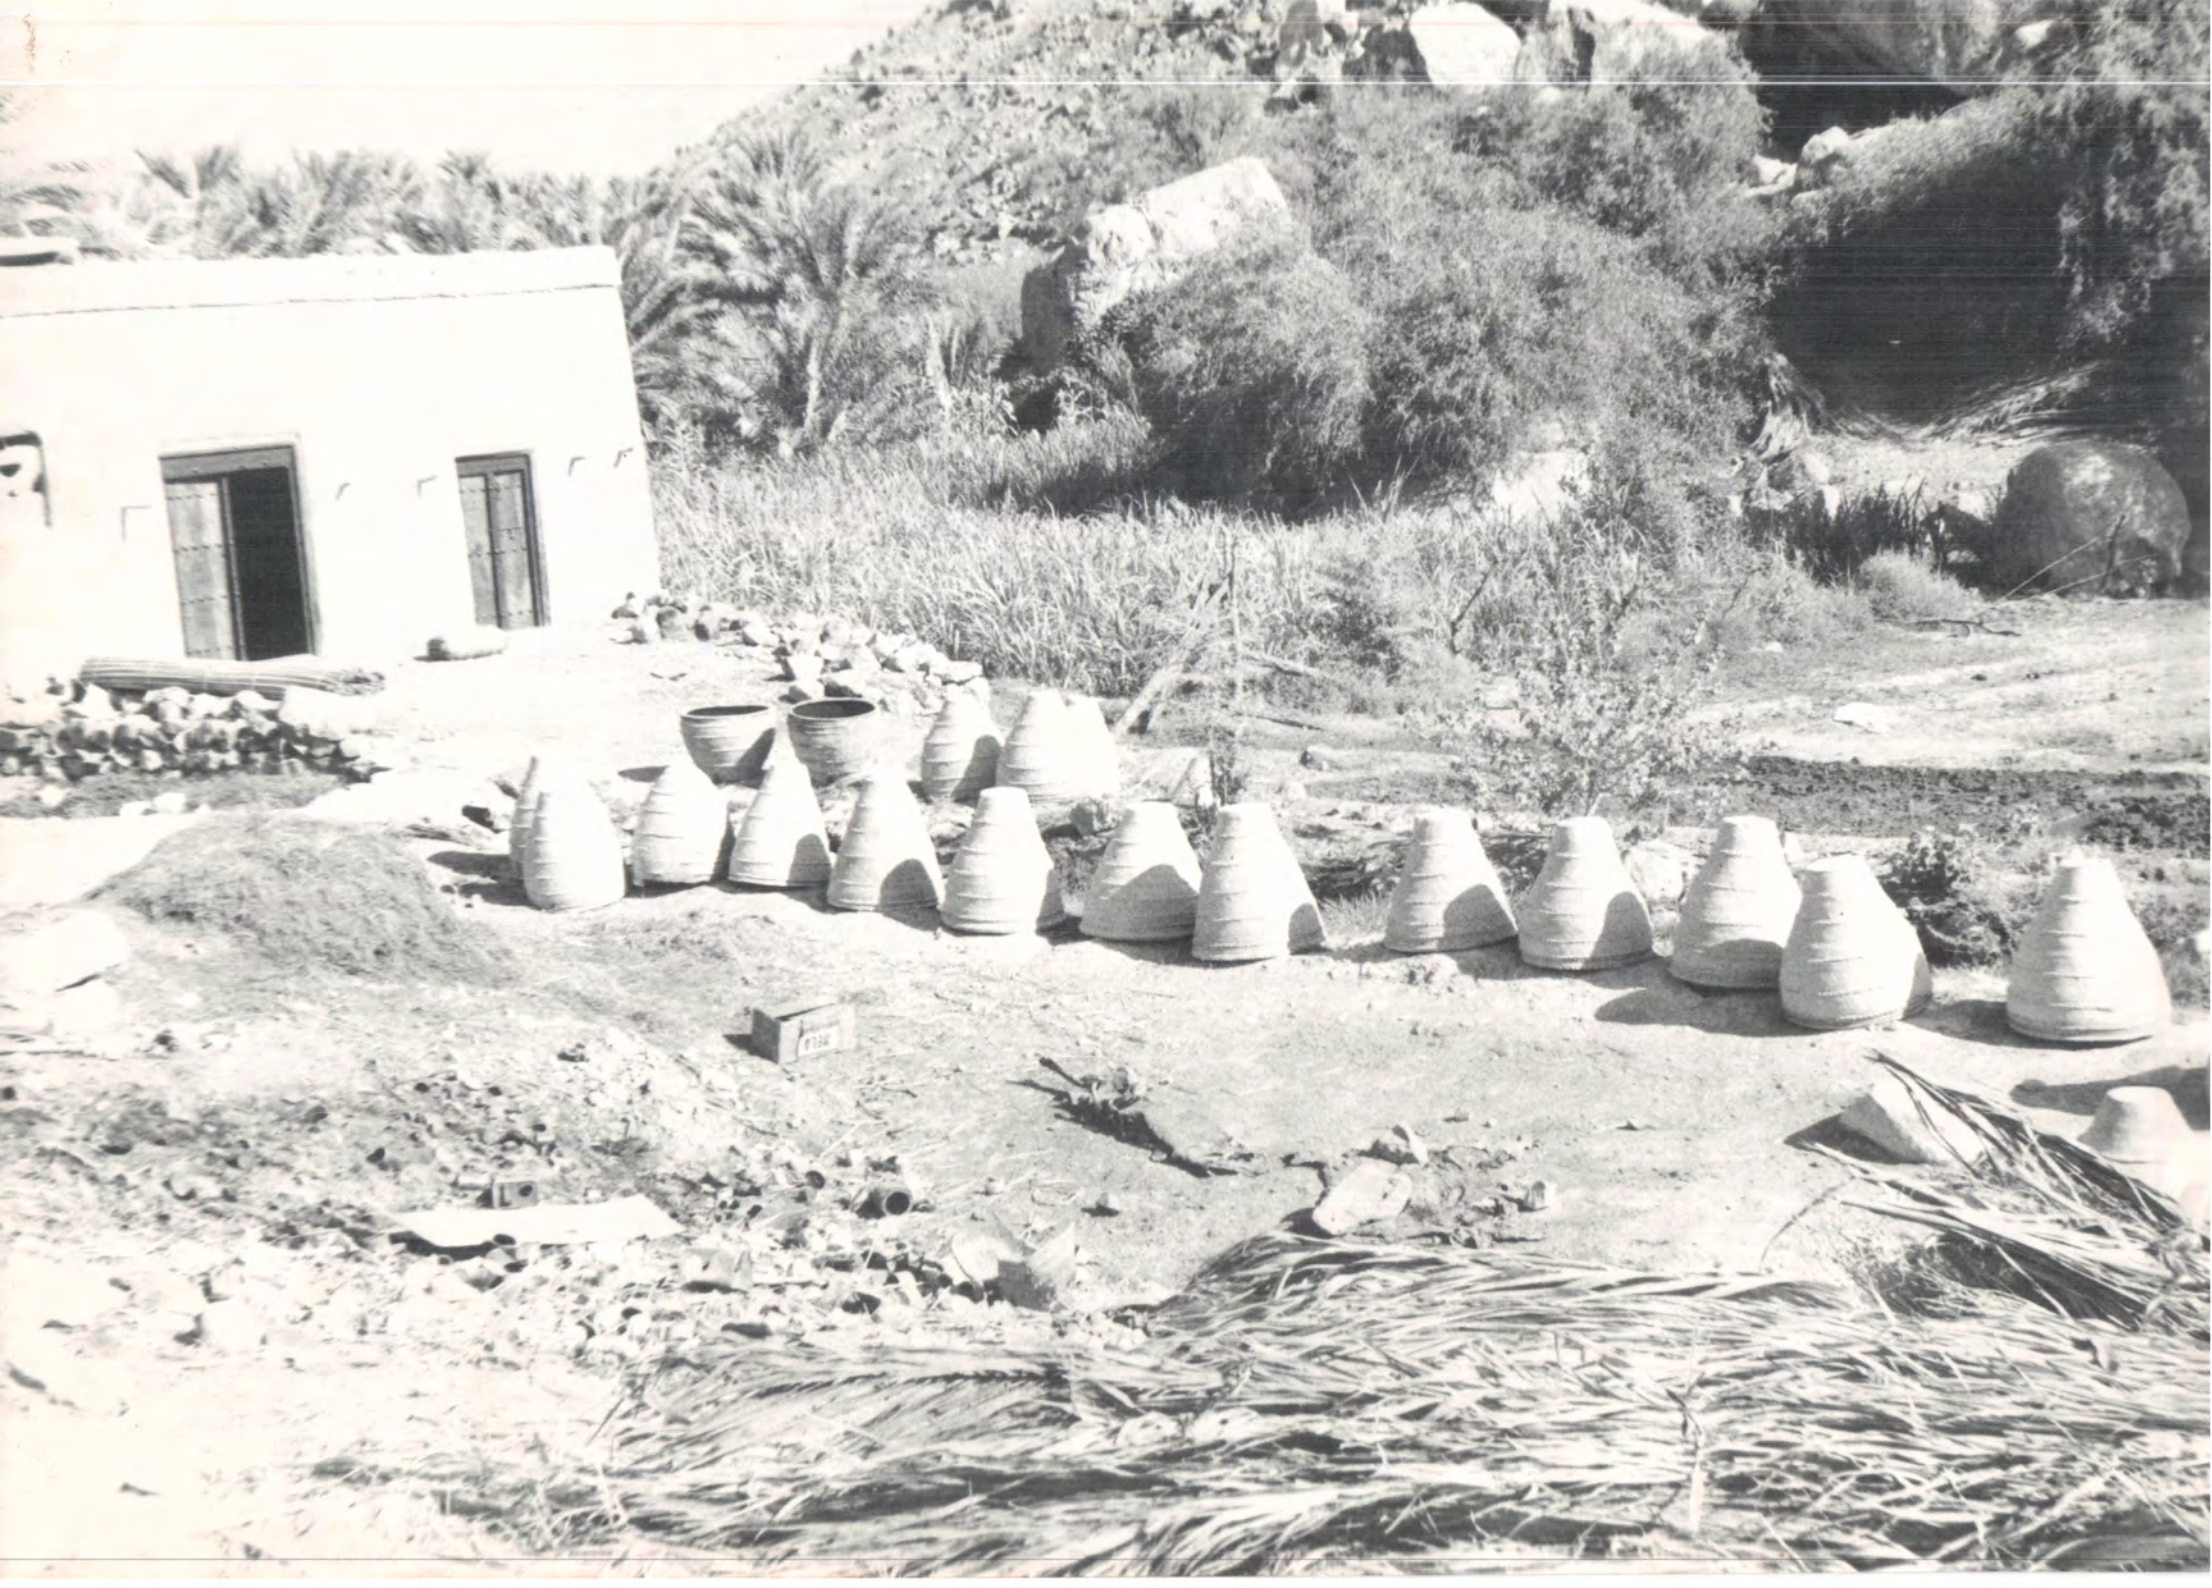
Fig 404

Drawings showing the effect of valley winds modified by daytime upslope & nighttime downslope local winds.

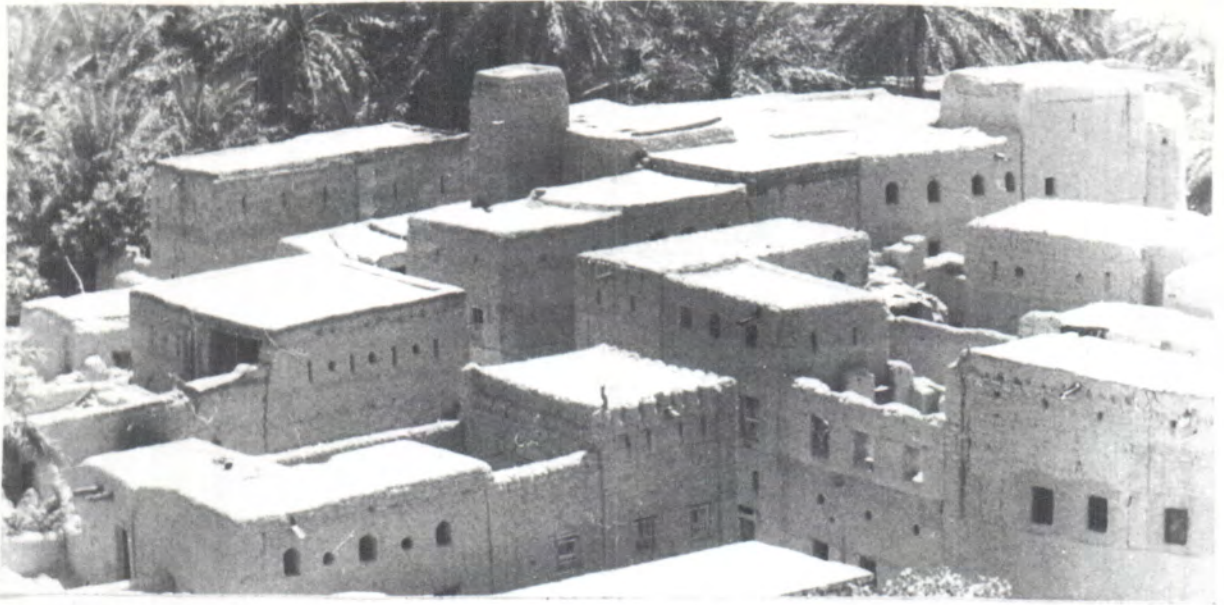
Construction of the traditional Flat Roof becomes a problem when timber is expensive or unavailable.

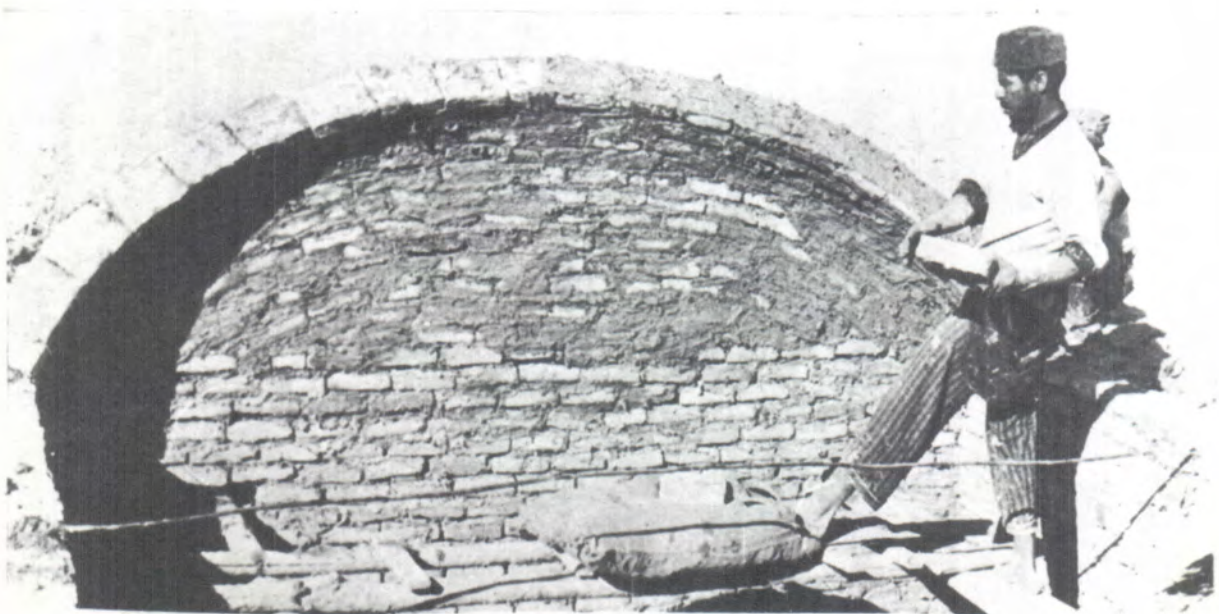
Mud Brick Vault + Dome Construction can provide inexpensive roofing.
