A STRATEGY FOR DEVELOPING  
INDIGENOUS BUILDING IN  
EARTHQUAKE REGIONS

CASE STUDIES OF THE BANDAR ABBAS 1977 EARTHQUAKE  
AND THE ZARAND 1978 EARTHQUAKE

BY  
DEVELOPMENT WORKSHOP

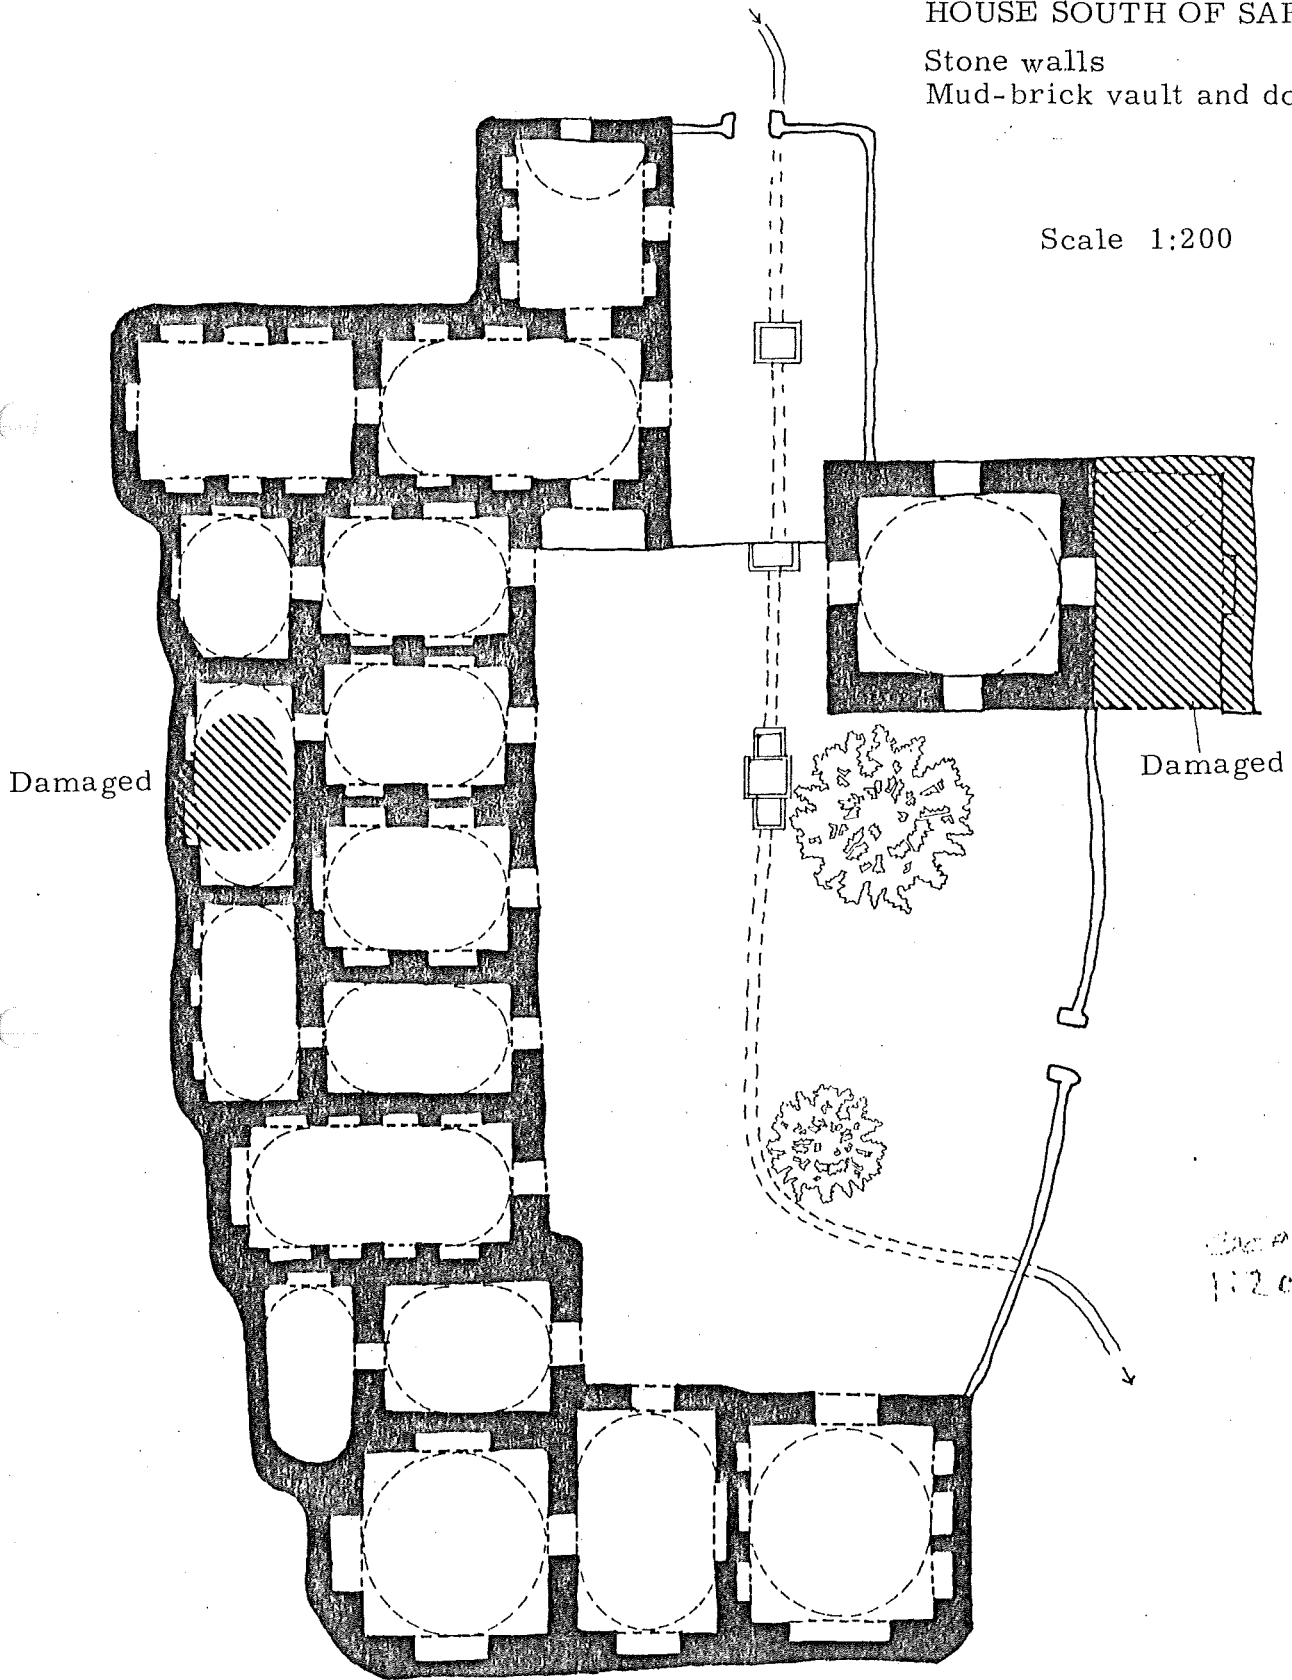
Damaged

Built of rubble stone walls with mud mortar and stone roof vaults with gypsum mortar. Total collapse of end room and major damage to other rooms

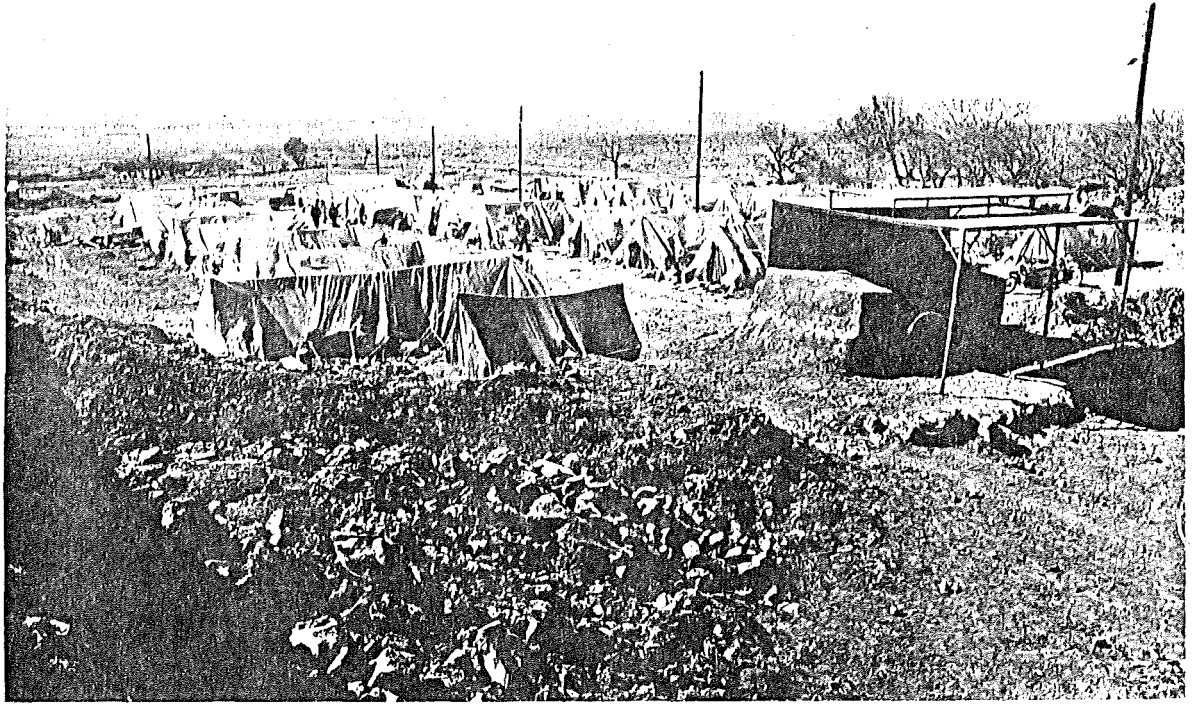
Sar Bagh:

Government provided emergency shelter for homeless.

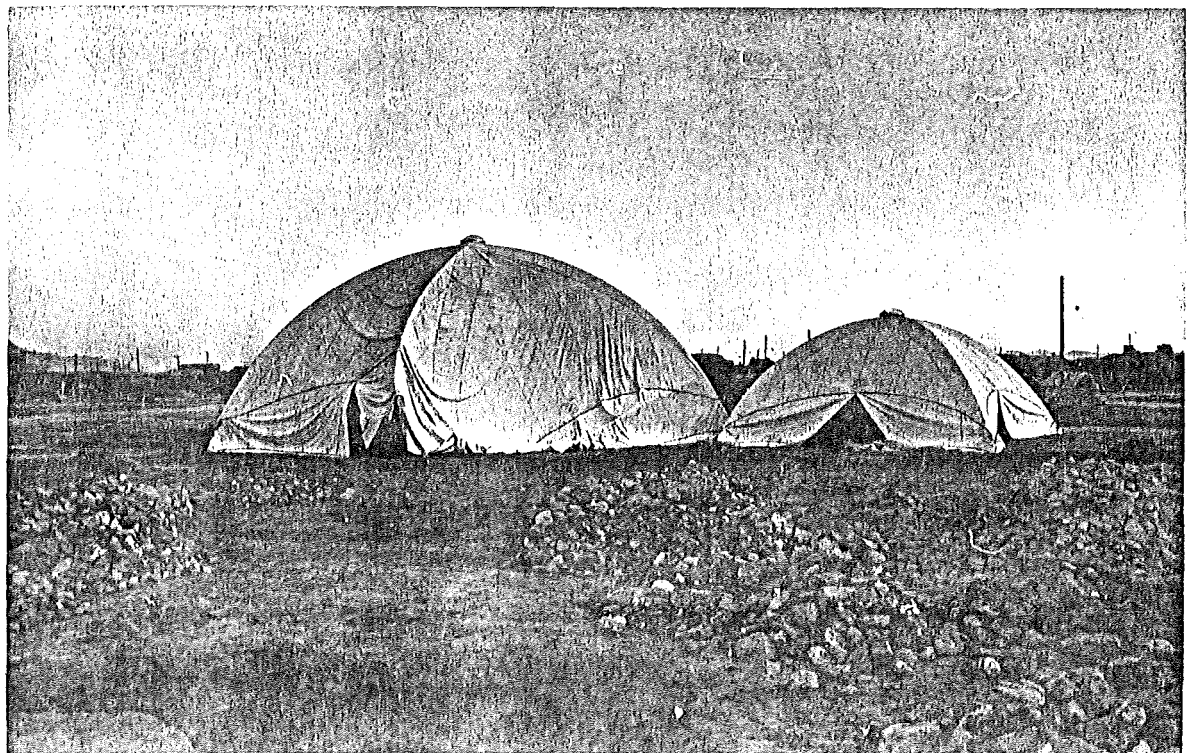
Zarand:

Government provided emergency shelter for public services .

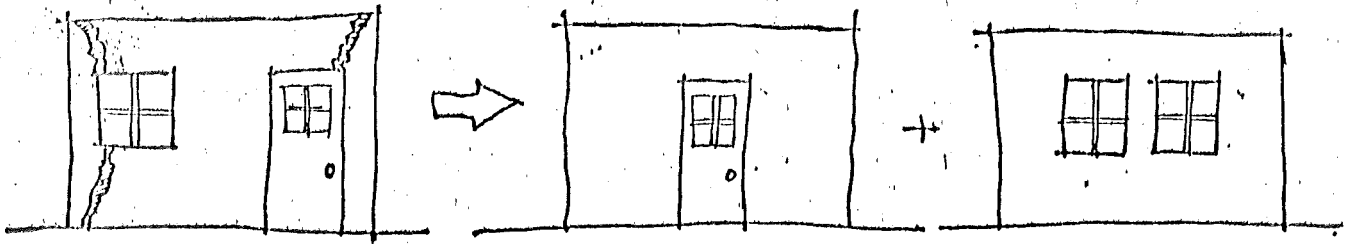
Because of stress concentration, openings should be avoided near corners of buildings.

Therefore it is better to position openings centrally on the walls.

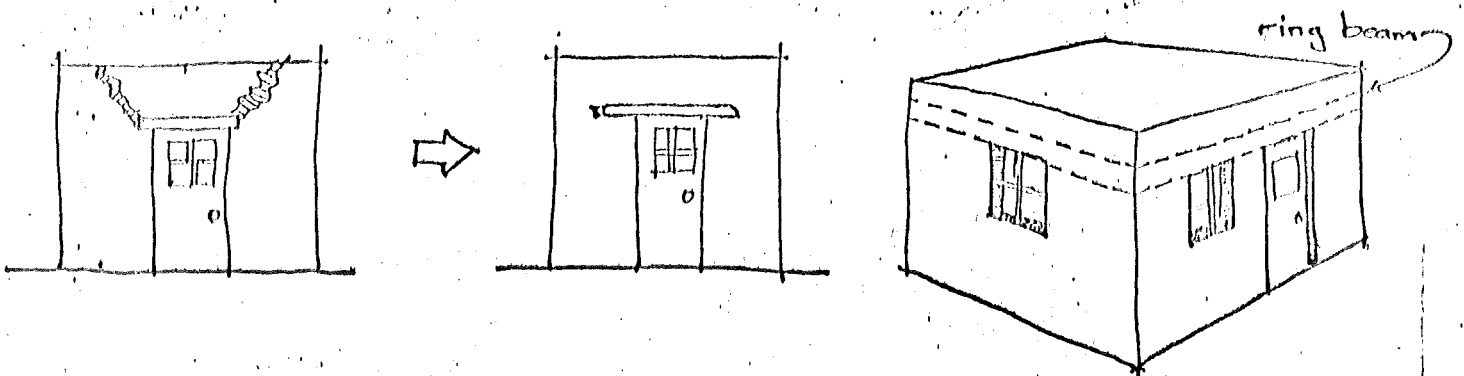
Cracking and failure often occurs above door and window openings. These areas can be strengthened by extending lintels deep into walls or by using continuous reinforced ring beams as a common lintel above all openings, with extra reinforcing at corners.

Such ring beams serve a double function in tying walls together to prevent movement which could cause roof collapse.

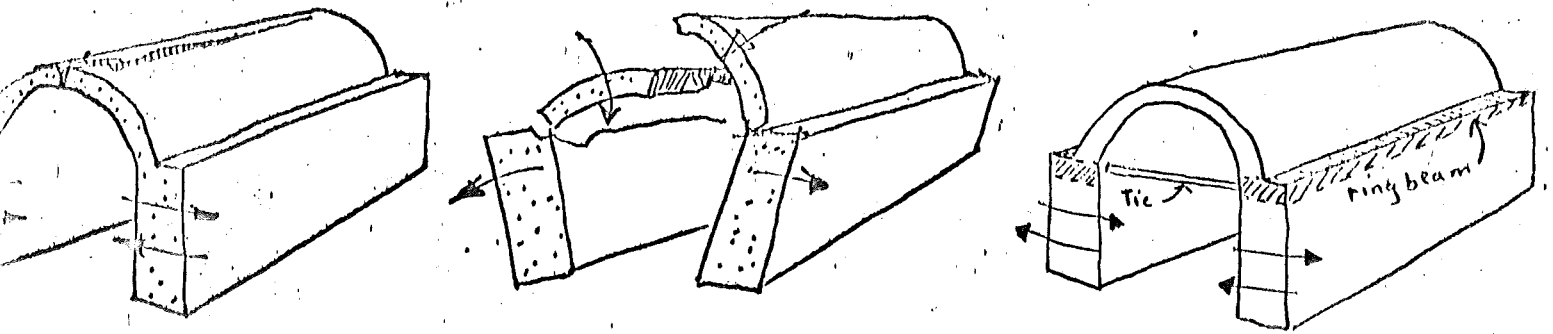
Vaults are much more susceptible to earthquake damage than domes. Any movement of walls upon which the vault rests will cause cracking in and failure of the roof.

A tie rod connecting the two side walls, which should have a continuous ring beam at the base of the vaults, will resist earthquake damage.

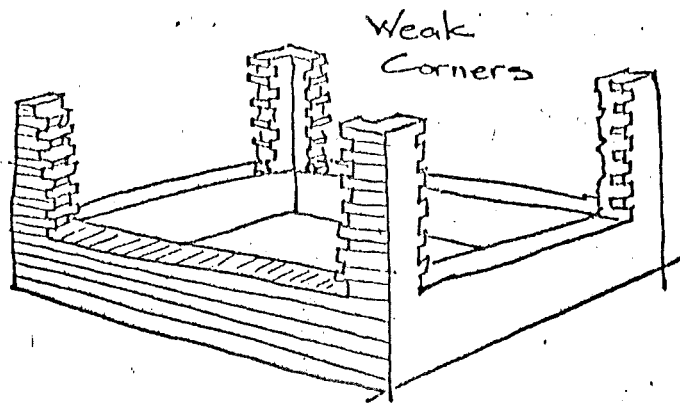
Bonding Corners: it is common practice in Iran to build up corners before infilling the wall. This is done to simplify the problems of lining up and levelling. This practice produces badly bonded and weak corners.

Since corners are critical stress areas, this practice should be discontinued. Brick courses should be laid continuously and wall building should progress evenly.
